Re: Annual maintenance review of your buildings located at 545 Manchester and 520 Dunedin St. Victoria, BC.

Test Report

Field Performance of Windows Performed in General Conformance with ASTM E 1105-00 (08)

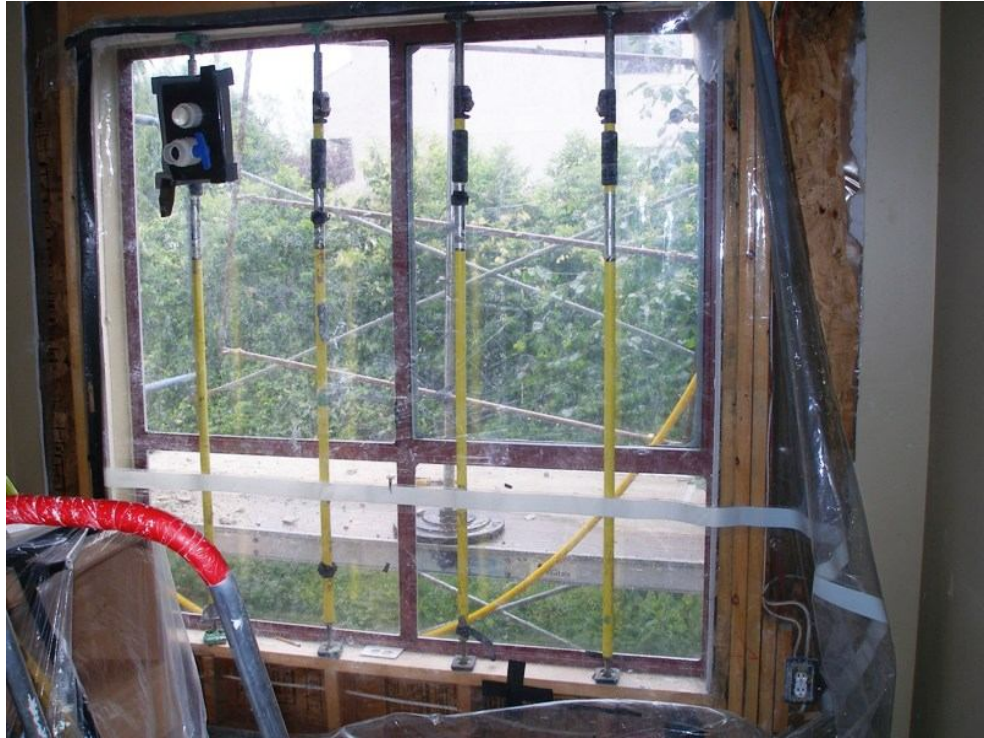
Test 1

Test-1, June 09, 2010, 217 North-East Facing Bedroom Window

In this test one 71" X 72" XO/OO window was tested. A negative pressure differential of 200pa was applied to the interior of the test chamber and the water spray rack was turned on. Water quickly filled the horizontal mullion, and the test was stopped. The sliding sash was taped off using duct tape on the exterior between the sash and the perimeter, and the exterior drain holes were taped off on the exterior to prevent water from accumulating too quickly in the sill track. The test resumed for the full four cycles with no visible evidence of water infiltration through the window frame or the window-wall interface.

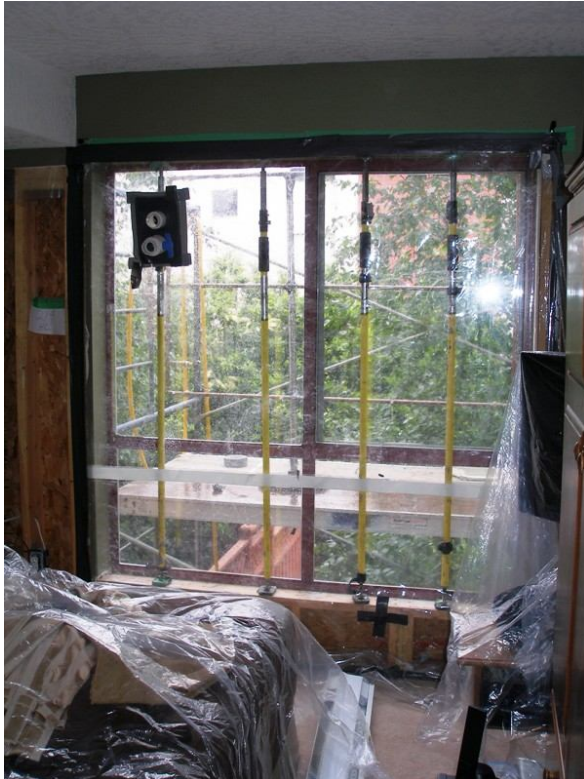
Test 2

Test-2, June 09, 2010, 214 North-East Facing Bedroom Window

In this test one 71" X 72" XO/OO window was tested. The sliding sash was taped off using duct tape on the exterior between the sash and the perimeter, and the exterior drain holes were taped off on the sill to prevent water from accumulating too quickly in the sill track. A negative pressure differential of 300pa was applied to the interior of the test chamber and the water spray rack was turned on. The test ran for the full four cycles with no visible evidence of water infiltration through the window frame or the window-wall interface.

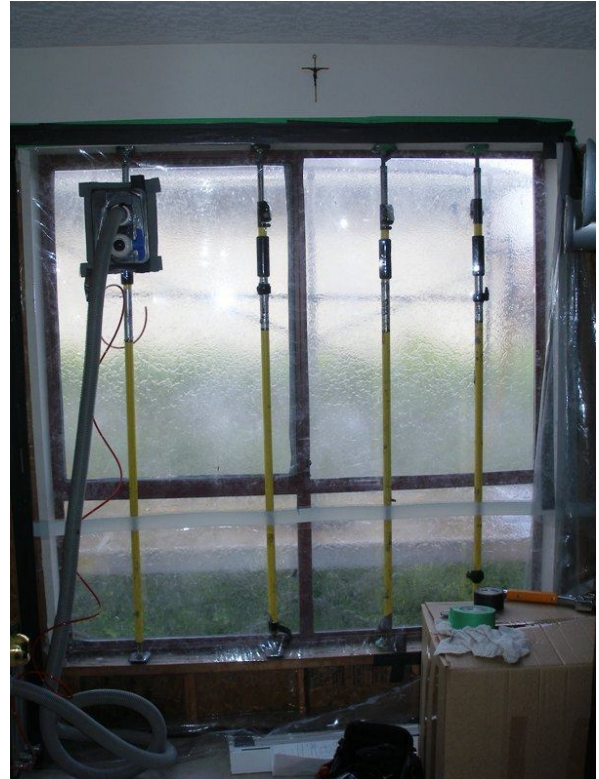
Test 3

Test-3, June 09, 2010, 212 North-East Facing Bedroom Window 'Churchill Building'

In this test one 71" X 72" XO/OO window was tested. The sliding sash was taped off using duct tape on the exterior between the sash and the perimeter, and the exterior drain holes were taped off on the sill to prevent water from accumulating too quickly in the sill track. A negative pressure differential of 150pa was applied to the interior of the test chamber and the water spray rack was turned on. The test ran for the full four cycles with no visible evidence of water infiltration through the window frame or the window-wall interface.
