Depreciation Report Level I

Prepared for Strata VIS 2720's 2013 Fiscal Year

27/1/2014

Strata VIS 2720
545 Manchester Road and 520 Dunedin Street
Victoria, B.C.

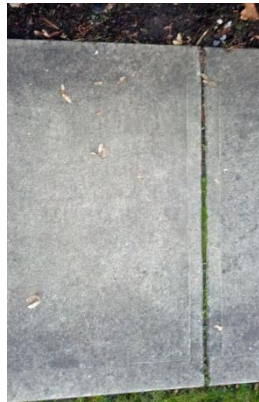
Concrete Sidewalks and Patios: Replace			
Quantity		UL	n/a
Current Cost	\$0.00	RUL	n/a

Generally fair condition with no widespread concerns. Complete any repairs as needed utilizing the operating budget. We recommend regular pressure washing to minimize slip and fall hazards and appearance. No expectation of large scale expenses at this time, therefore, no reserve funding recommended.

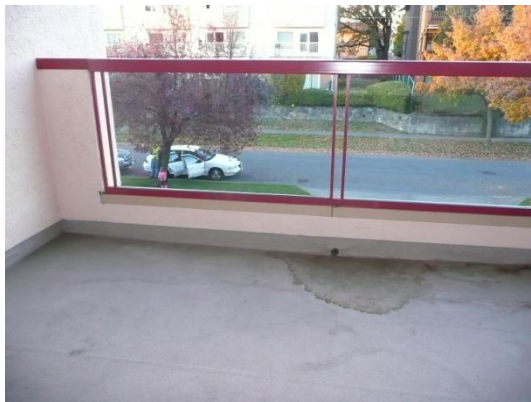
Quantity	1500 square feet	UL	n/a	
Current Cost	\$10,500.00	RUL		0

The elevated decks throughout the Strata utilize a vinyl membrane for weatherproofing and protection of the structure. Currently the surface of the decks are in generally poor condition. These surfaces are extremely important and there is a significant risk of water intrusion to the deck and surrounding structure when they fail. The vinyl on the south and west elevations are aged and brittle and should be replaced in the near future; the decks on the east and north elevations should survive approximately 5 years. Proper detailing at the walls and sliding door threshold will need to be implemented. We recommend the use of a liquid applied membrane coating to extend the life of the vinyl until the windows and stucco are replaced. This phase is for the south and west balconies only.

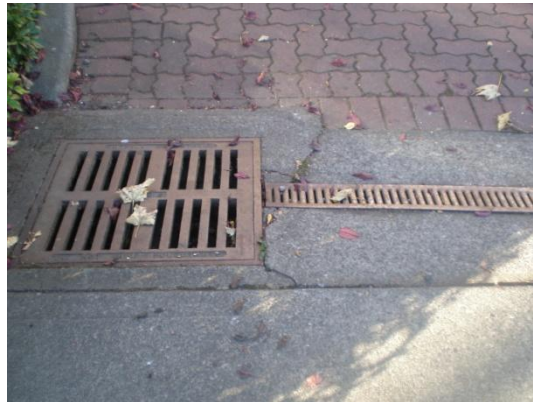
Drainage			
Quantity	1 allowance	UL	5
Current Cost	\$4,000.00	RUL	5

We understand there is no history of drainage concerns. We recommend regular cleaning and video camera inspection take place to ensure that these function properly. An allowance on a recurring 5 year basis to maintain the functioning of the drainage system is included.

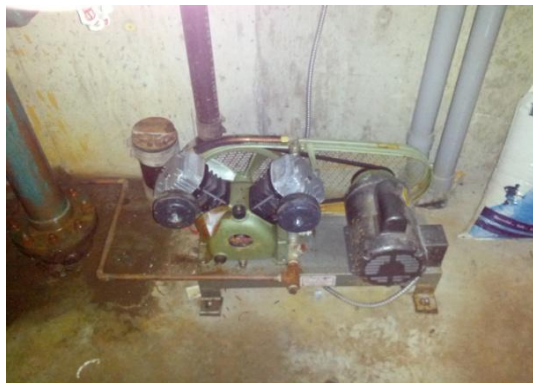
Dry Fire Suppression System			
Quantity	2 allowance	UL	25
Current Cost	\$20,000.00	RUL	5

The dry portion of the fire suppression system has a number of components that will need to be replaced at varying ages. These include valves, flow detectors, compressors and switches.

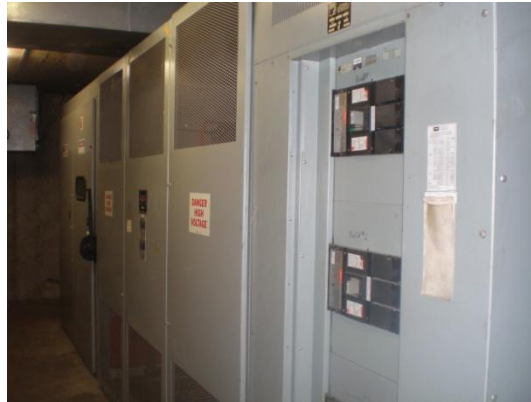
No reported problems. Analysis of the electrical system is beyond the scope of a Depreciation Report. At this time, there is no expectation of significant repair or expenses required. An inspection by an electrical engineer or electrical contractor would warn the Strata Council of any current problems and allow them to be repaired or replaced on a non emergency basis. This inspection could include the use of infrared or thermographic equipment to detect hot spots. We recommend regular inspections of the system by a qualified electrician incorporating the results into future Depreciation Report updates.

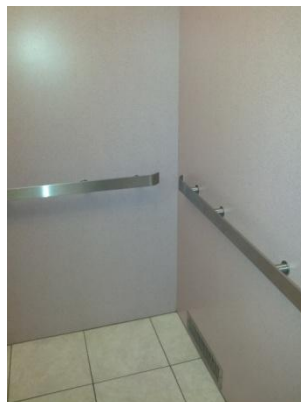
Fair condition but looking dated due to the colour of plastic laminate used. We understand that the elevator cabs have the original interiors. Replacement is discretionary as this is done for aesthetic reasons only. It could be combined with an updating of the lobby flooring and furniture.

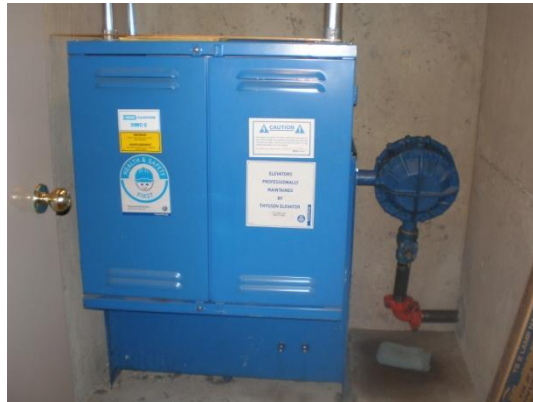
Reportedly functional with no major concerns, however, this original elevator is approaching the end of the typical useful life of 30 years. This component includes funding for a new controller, pump unit, electrical, etc. While we don't anticipate the need to replace the hydraulic ram at this time, we suggest that it be inspected.

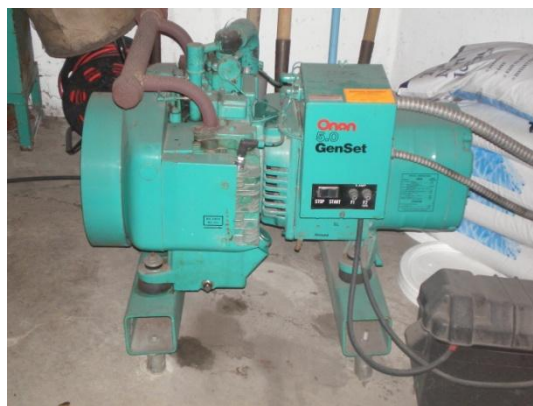
Emergency Power Generator: Replace

Reportedly functional with no major concerns, however, this original generator is approaching the end of the typical useful life of 30 years. Funding recommended.

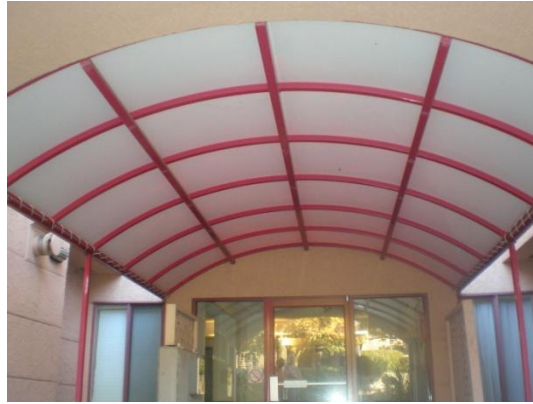
Entrance Canopy: Replace

The entrance canopies are vinyl fabric stretched over a painted metal frame. The canopy on Churchill Place is south facing and will need to be replaced sooner than that on Hampton Court due to its north facing and more shaded exposure. Annual cleaning and inspection recommended from the operating budget.

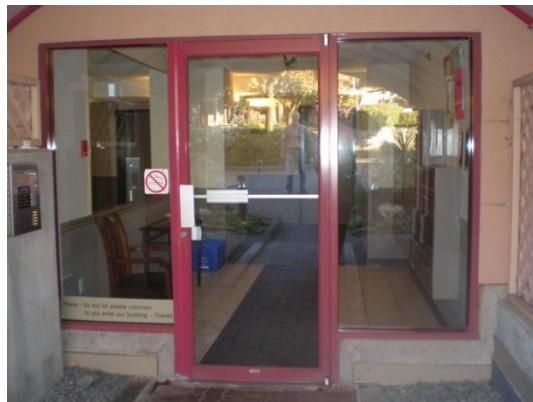
Entry Doors: Replace

Fair condition with no widespread damage or deterioration. Repair as needed utilizing the operating budget. While these storefront doors and adjacent glazing will last indefinitely if properly maintained, advances in the glazing industry are expected to continue over the coming decades and replacement at the 50 year point in the life of the buildings is reasonable to plan for.

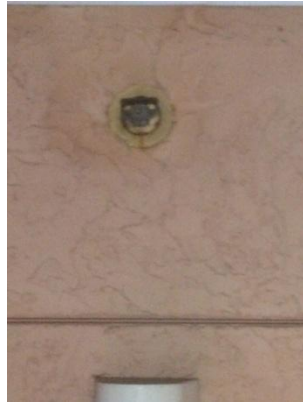
Exterior sprinkler heads			
Quantity	84 each	UL	50
Current Cost	\$100,800.00	RUL	10

When the building exterior is replaced the exterior heads of the fire suppression sprinkler will need to be replaced. These are significantly more expensive to do than the interior heads due to the need to open and repair the ceilings and/or walls in the occupied suites.

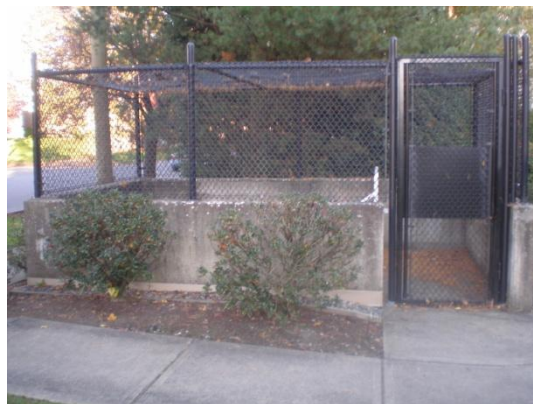
Fence: Chainlink, Replace			
Quantity	44 lineal feet	UL	30
Current Cost	\$2,200.00	Cost Source: Tower Fence	RUL 10

Good condition of the galvanized chain link fencing. The life expectancy of these units is approximately 30 years. Reserve funding recommended.

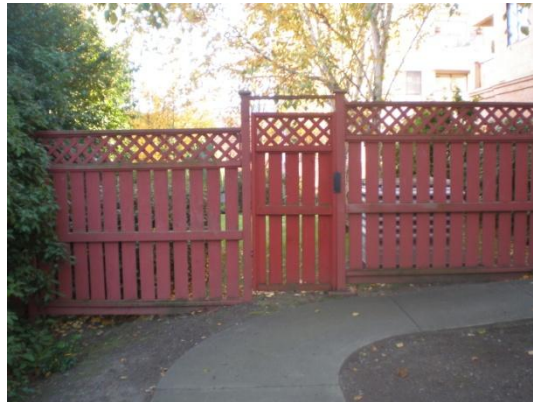
Fence: Wood, Replace				
Quantity	62 lineal feet		UL	20
Current Cost	\$2,170.00	Cost Source: Tower Fence	RUL	11

Fair condition of wood fencing with no unusual deterioration. Reportedly the Strata Council inspects and repairs regularly utilizing the operating budget. Remove any contact with the ground and overgrowth to minimize advanced deterioration. We suggest continuing to seal for appearance and protection of fencing. Reserve funding is provided for the replacement at approximately the 20 year mark of life.

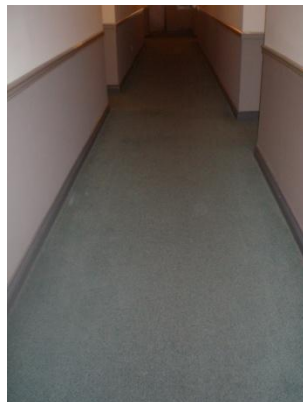
Finish Flooring: Carpet, Replace				
Quantity	1300 square yards		UL	10
Current Cost	\$45,500.00		RUL	3

Corridor and stair carpeting is worn and stained in several areas. We recommend a shorter replacement cycle of approximately 5 years for the garage lobby carpet to maintain appearances and property value with funding from the operating budget.

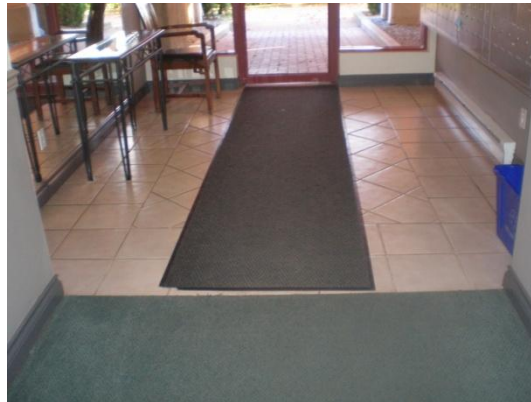
Finish Flooring: Tile, Replace

Lobby tile is in good condition and is a highly durable product. However for aesthetics and to maintain property values a cosmetic upgrade will likely be needed by the 40 year point of the buildings' lives. Replacement is discretionary as it will likely be for aesthetic reasons only.

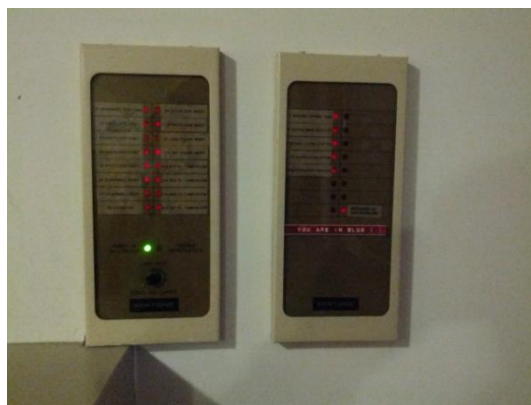
Fire Panel: Replacement

Reportedly functional condition with no problems at this time. Generally these panels can last for an extended period of time barring a damaging electrical event. However, funding is included for repair/replacement and anticipated upgrade needs.

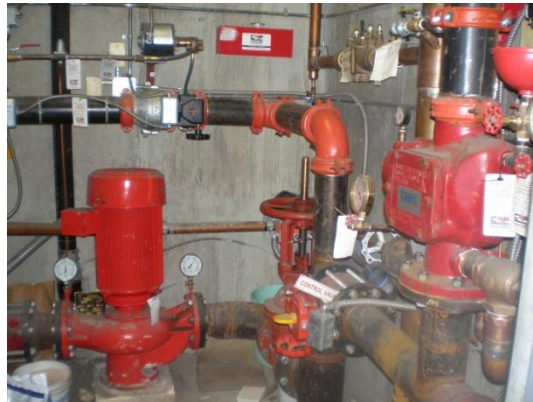
Sprinkler heads are required to be replaced at the 50 year point in the life of the buildings. Funding required.

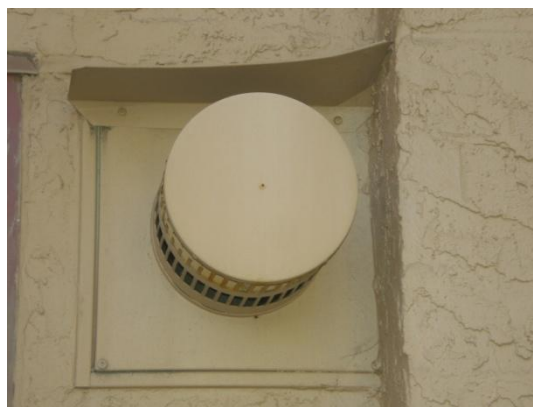
These will need to be replaced at the time of replacing the building exterior cladding.

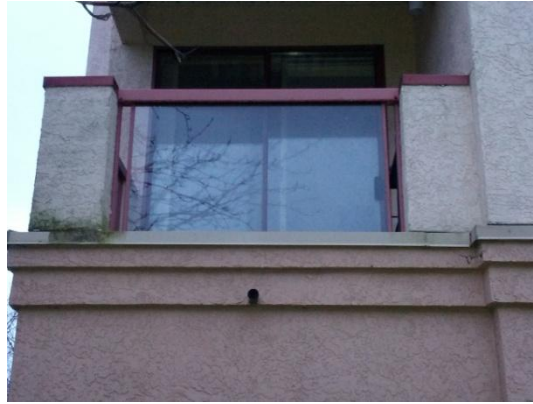
Fair condition with no reported or observed instability noted during our limited scope visual inspection. We recommend ongoing and regular examinations. Clean as needed for appearance (these units are powder coated and therefore there is no need for paint). We recommend planning for eventual replacement at the time of the window and stucco replacement. The Strata Council may wish to change the design with the framed and stuccoed ends and corners as a part of the exterior upgrade/replacement.

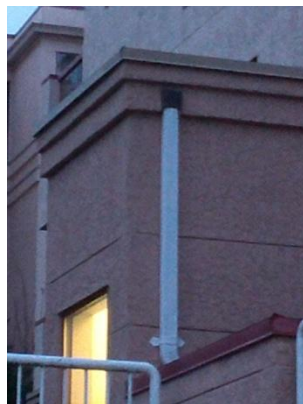
In general keep clean and free of debris to ensure proper functionality. Reserve funding recommended for replacement timed to coincide with stucco replacement.

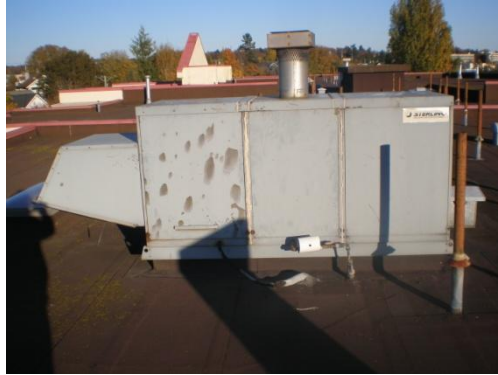
Reportedly in functional condition with no concerns at this time. Reserve funding recommended for replacement.

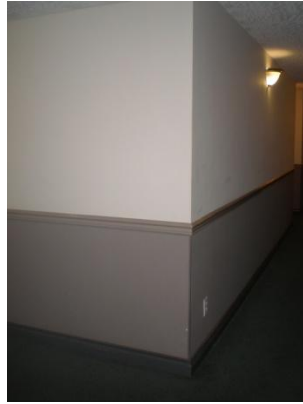
Interior painting of corridors, stairs and doors. Reserve funding recommended.

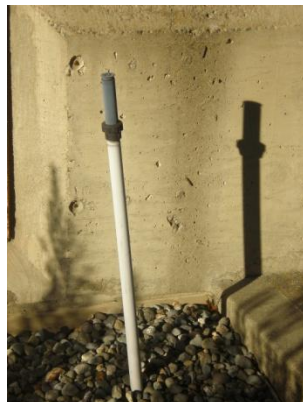
Fair condition with no reported problems at this time. We understand that irrigation maintenance is included within the Strata's annual landscape budget/contract, such as select sprinkler head replacements. As the community and irrigation lines age, local areas of line replacement may be needed and generally this is not covered by the landscape contract. At this time there is no expectation of total line replacement, however, as these expenses occur and trends are developed update the reserve funding as needed.

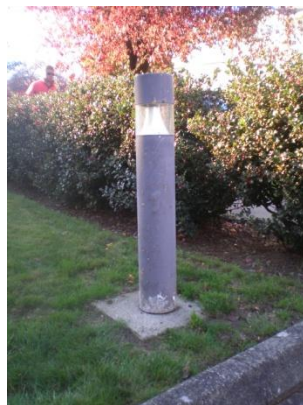
Reported to be in functional condition with no concerns at this time. These are sturdy items that can last a long time if not damaged or abused. Inspect regularly and repair as needed utilizing the operating budget. Reserve Funding recommended for eventual replacement.

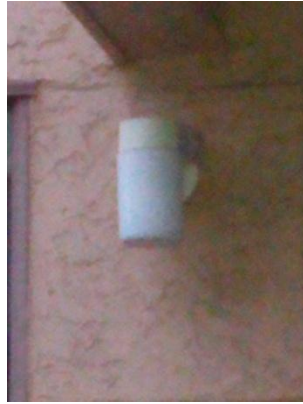
Good condition with no unusual deterioration or instability observed. No history of concern. Repair as needed from the operating budget. Best to plan for total replacement for appearance and functionality and time of exterior upgrading.

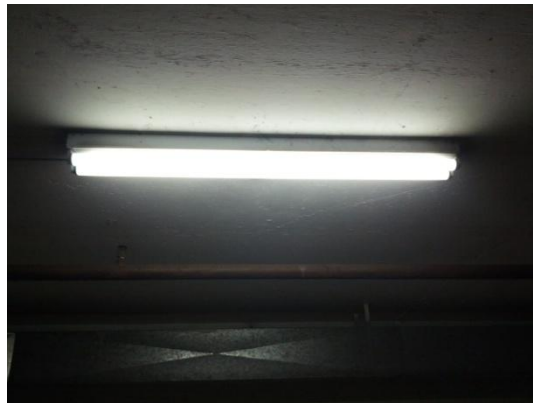
Fair condition with no unusual deterioration observed. Repair as needed from the operating budget. The Strata is considering replacing these with newer ones as the ballasts are failing and becoming difficult to source.

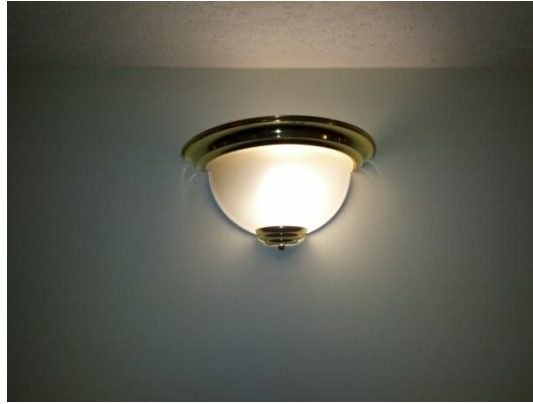
Good condition with no unusual deterioration or instability observed. No history of concern. Repair as needed from the operating budget. Best to plan for total replacement for appearance and functionality. Upgraded from incandescent to compact fluorescent in the past.

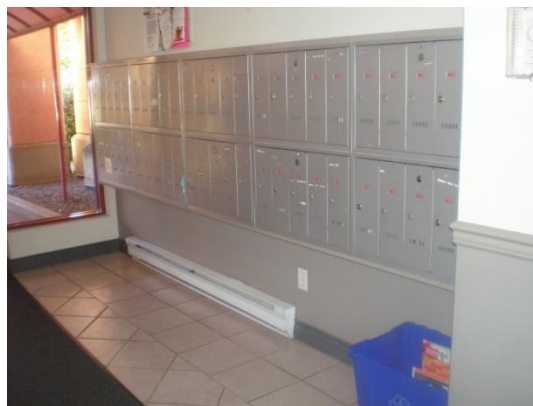
Fair condition of mailboxes with no unusual damage observed. Clean as needed to maintain appearance. We suggest planning for eventual replacement of the mailboxes to ensure functionality and community aesthetics.

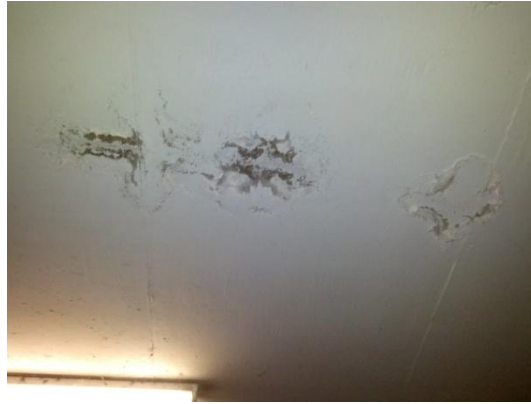
Fair condition with some observed water intrusion as evidenced by the efflorescent salts in a few locations. We recommend repairing the areas where water is already penetrating the concrete roof structure from the operating budget and funding for eventual replacement. Costs would include replacing unit pavers, relandscaping and replacement irrigation system.

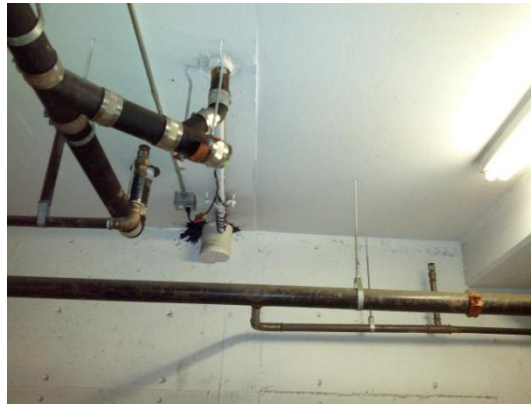
No reported problems. Analysis of the plumbing system is beyond the scope of a Depreciation Report. There is no history of building plumbing expenses reported. No expectation of large scale repair or replacement expenses within the scope of this report. We recommend regular video camera inspections and repair as needed. Should patterns of expense develop, funding maybe updated in future Depreciation Report updates.

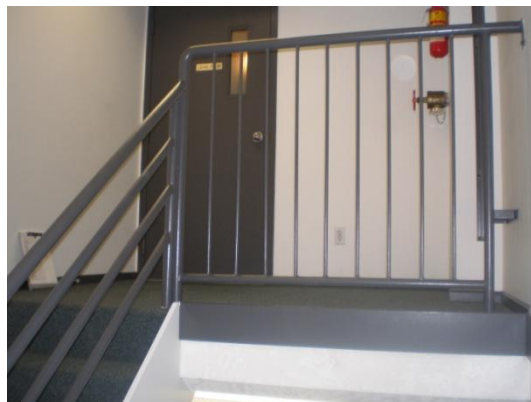
These railings at the stairwells and over the ramp to the underground parking are highly durable. Fair condition with no reported or observed instability noted during our limited scope visual inspection. We recommend ongoing and regular examinations of connections to underlying structure for safety reasons. Clean and repaint as needed for appearance from the operating budget. No funding recommended at this time.

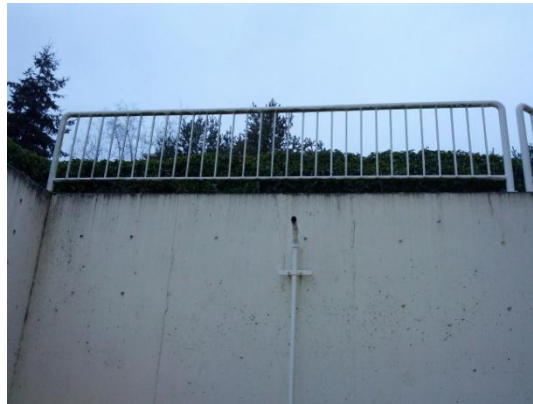
Good condition with no known instability or concerns identified. Should conditions change, we recommend a thorough evaluation be conducted by qualified structural and geotechnical engineers. No reserve funding at this time.

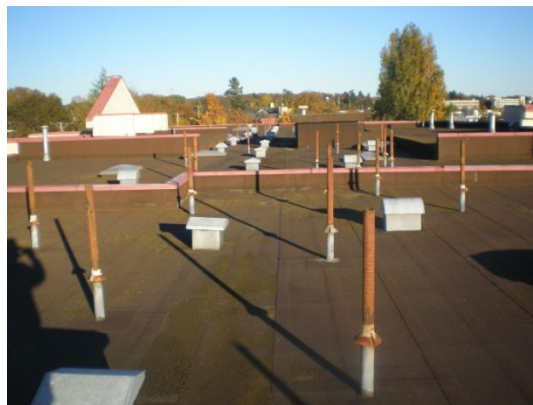
Fair condition with no known concerns or issues, such as water intrusion. We recommend regular maintenance and cleaning activities take place to keep roofs free of debris and moss. With proactive maintenance, reserve funding recommended replacement at approximately 25 year mark of life.

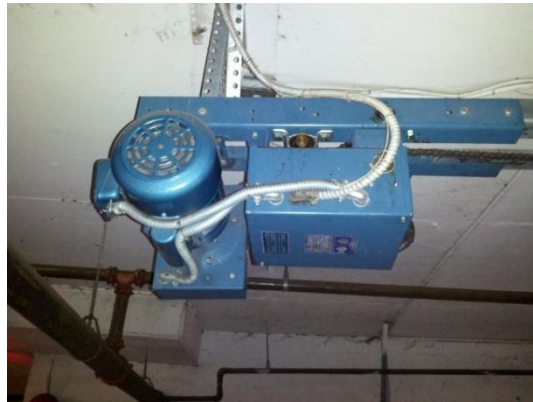
Fair functional condition with no concerns at this time. We recommend working with a qualified vendor to develop and establish an operating and maintenance plan. Reserve funding recommended for cycles of replacement.

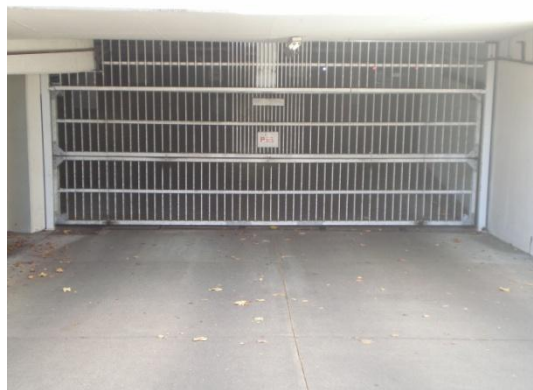
Generally fair condition, however, local areas of dents and damage (not widespread). These units can last an extended period of time if not damaged or abused.

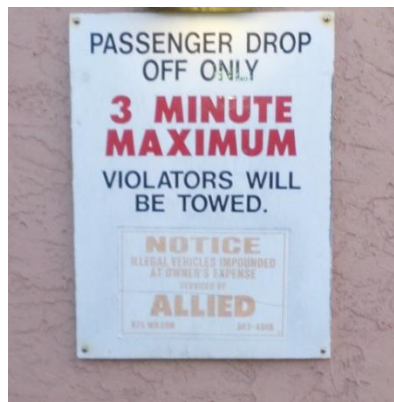
Fair condition with no damage or concerns at this time. We understand there is no expectation to replace at one time, therefore, no reserve funding. Treat as a maintenance item and fund from the operating budget.

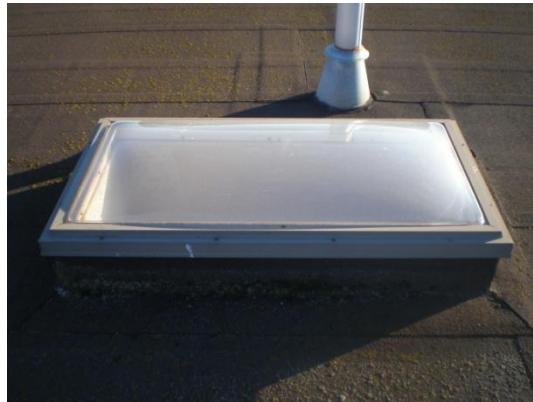
Skylights are part of the roof system and should be replaced on the same cycle.

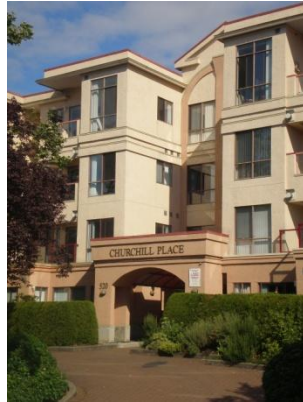
Fair condition of stucco with some observed repairs done to flashings. The Strata has been practicing a proactive inspection and maintenance program, however by the 30 - 40 year point in the life of the buildings the windows will be obsolete and will need to be replaced. At that point the cladding will need to be replaced to install the new windows and sliding glass doors properly, using current best practice, which may well be further improved by then. We anticipate that the cladding would be changed at that point to something other than stucco such as HardiPlank, subject to approval by the City if a Development Permit was issued for the original construction. If the Strata should choose to replace the stucco with new acrylic stucco the pricing used for this component will need to be increased significantly.

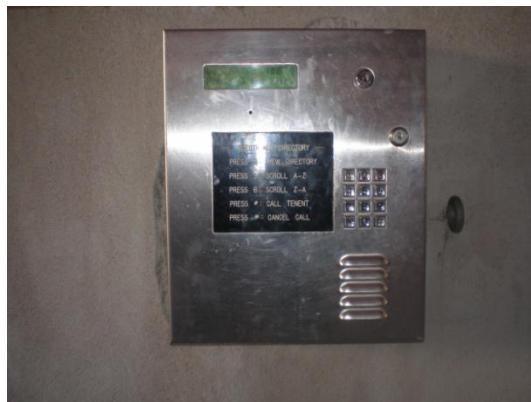
Reportedly in operation condition with no history of problems or concerns. Reserve funding recommended for replacement at approximately the 22 year mark of life.

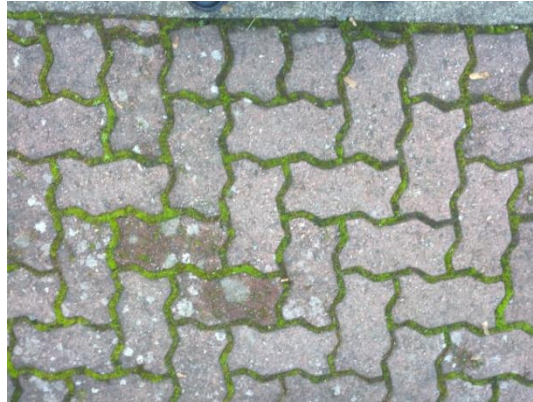
Unit pavers are a highly durable item as long as the underlying soil and sand bed are not eroded by water. N

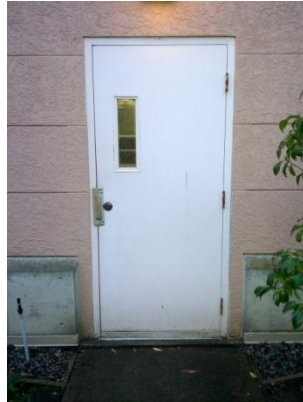
Fair condition with no widespread damage or deterioration. Repair as needed utilizing the operating budget. There is no expectation of a large scale replacement or surface refurbishment project, therefore, replace and/or refinish select doors as needed from the operating budget. By the 50 year point in the life of the buildings, the door hardware should be replaced as these wear out. The door slabs and frames will last indefinitely unless vandalized.

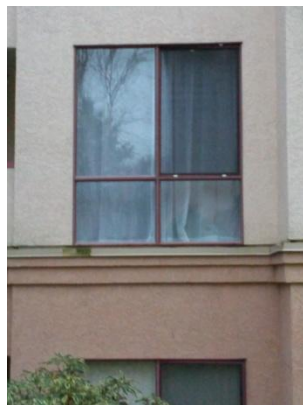
Generally fair condition with no known water intrusion or concerns at this time. The Strata has a proactive inspection and maintenance program that has repaired defects over the life of the building to date. We endorse this program of regular inspections and repair to ensure waterproofing of the building envelope. Reserve funding recommended for eventual replacement at the typical life expectancy of 30 years. Should patterns of repair arise, additional funding may be included in future reserve studies, however, at this time there is no need.
