Building Envelope Condition Assessment

Strata Plan 2720

Hampton Court 545 Manchester, and

Date: March 12, 2014

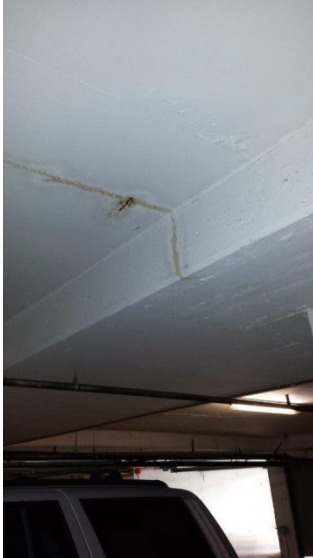
Parkade 13

There is one recent active leak noted in the parkade in the south west corner. See appendix e photo parkade 13.

1. I recommend excavation and repairing the area above the new leak in an attempt to stop or reduce the water ingress. This would also enable a closer look at the membrane once the soils have been removed. The Owners have already approved this recommendation with a targeted start date in the spring or summer of 2014.
2. I recommend a biennial inspection to monitor and record the extent of the water ingress. Recording the length and width of the cracks with water ingress and the extent of staining around the area show the degree or change in the amount of water ingress.

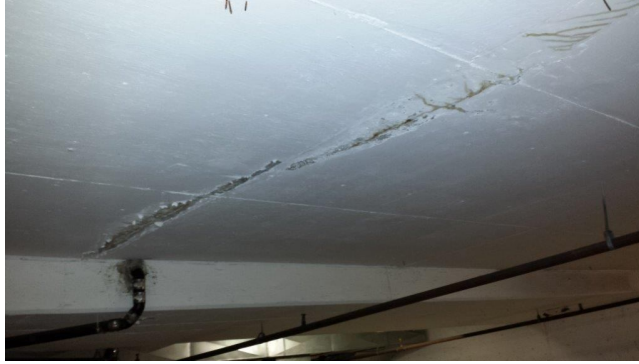
Parkade 14

Location of crack (approximate)	Condition	Photo
In front of parking stalls 99 -100	No indication of current water ingress	1 & 2
Above garbage bins	Membrane above repaired ingress greatly reduced	3
South side rt of driveway ramp	No indication of current water ingress	6
South side rt of driveway ramp	No indication of current water ingress	7
Under west stairs CP	Roof drain above repaired ingress reduced	9
Area close to sump	No indication of current water ingress	10
Slab above Upper corner of ramp	No indication of current water ingress	12
In front of parking stall 18 & 19	Recently identified repairs approved for future	13
In front of parking stall 150	Area above repaired ingress stopped	14
In front of parking stall 145, 146	Area above repaired ingress greatly reduced	15
In front of parking stall 56 & 57	Area above repaired ingress greatly reduced	16
In front of parking stall 142-144	Area above repaired ingress stopped	17-20

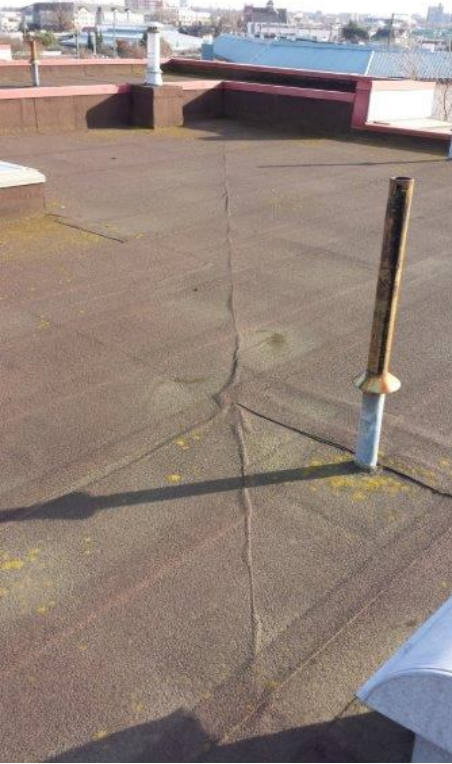
- There are some wrinkles in the membrane consistent with the age of the roof and normal structural movement. Appendix E photo Roof 1
- We noted signs of moss, algae, lichen and other debris. Appendix E photo Roof 3, 5, & 9
- There are some areas where seams are starting to open. Appendix E photo Roof 7

Roof 1 Wrinkled membrane

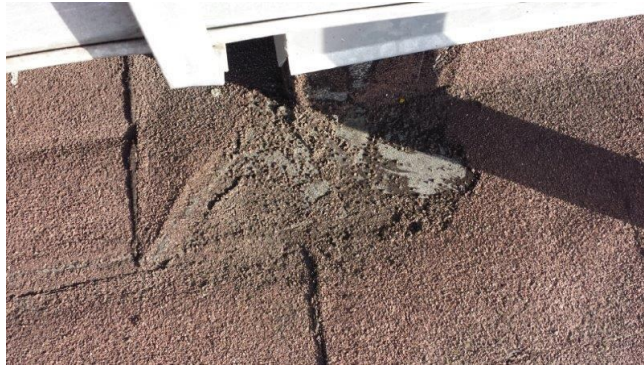
Roof 2 Missing granulars on membrane surface

1. Treat roof to kill moss and lichen.
2. Remove debris from roof.
3. Repair all open seams and re-granulate any bare areas of the cap sheet.

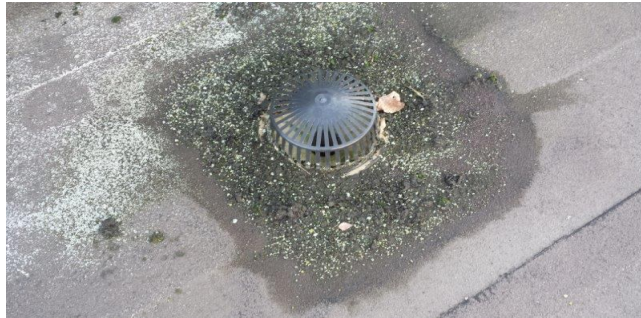
Roof 3 Debris around drain

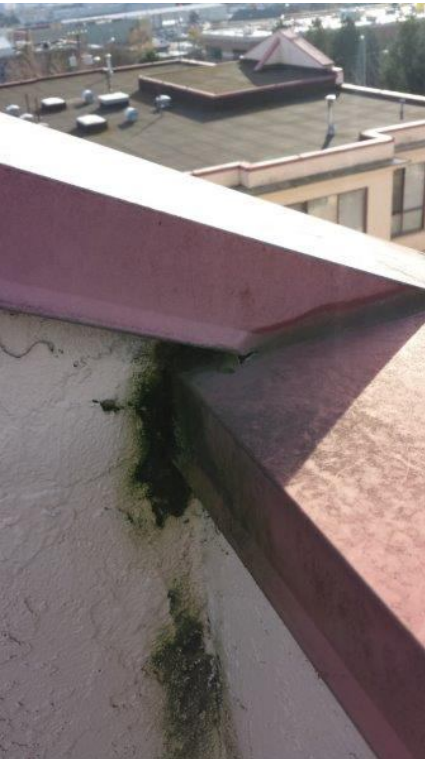
- Some of the caulking for the flashing is beginning to come apart and or fail.

Roof 4 Hole in caulking

1. Go over all areas of the flashing and repair or replace the caulking as required.

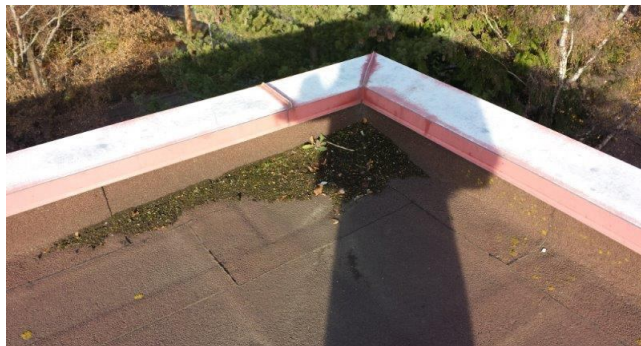
Roof #5 Debris

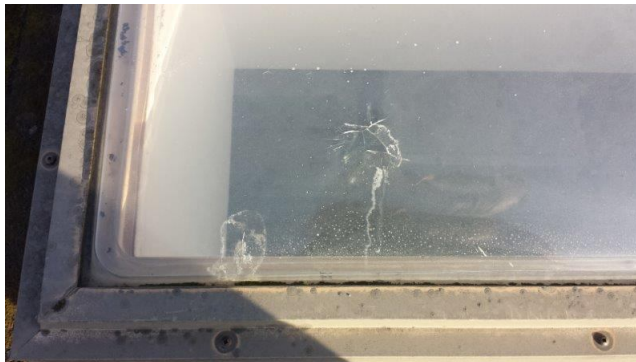
- There are areas of the vents that are starting to corrode at the base above the membrane. Appendix # photo Roof 8
- One of the skylights is failing and another has been damaged by a rock or shell likely being dropped by a bird. Appendix # photo Roof 6

Roof 6 Damaged Skylight

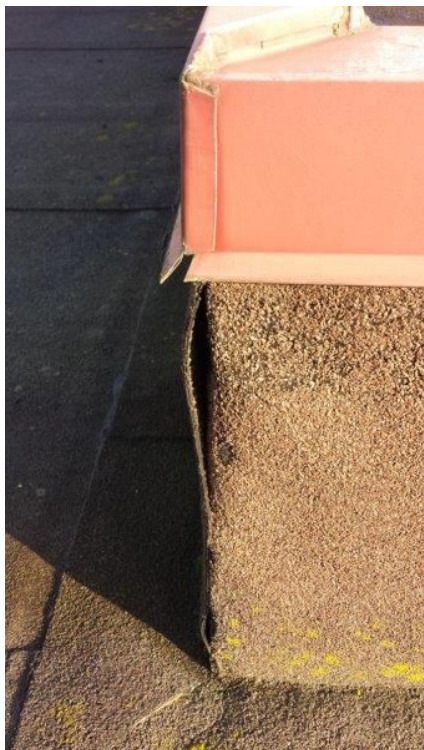
Roof 7 Open seam

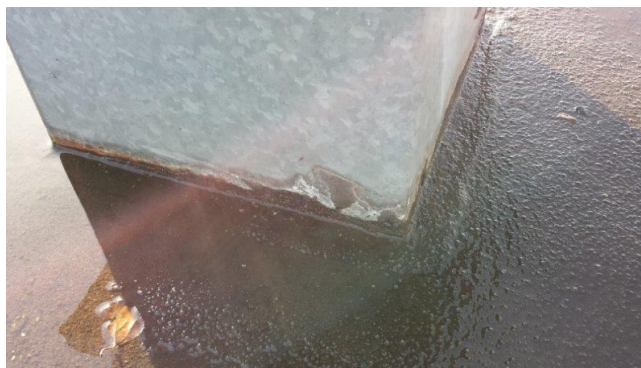
Roof 8 corrosion of sheet metal vent

1. Extend the membrane on the vents with signs of corrosion to stop the deterioration of the vents.

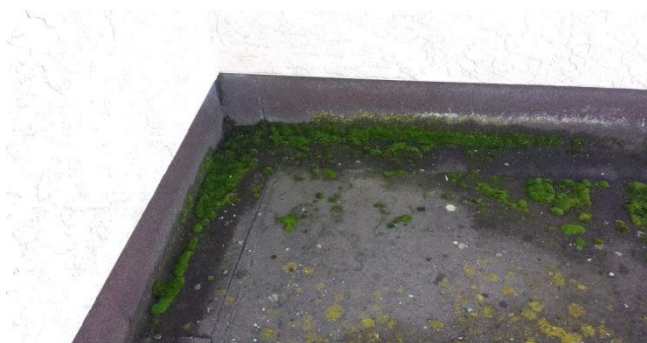
Roof 9 Moss & Lichen
