DougLes Consulting Services Incorporated

April 14, 1999

Re: Owners of Strata #2720's buildings located at 545 Manchester and Durban St. Victoria, BC.

As per your request I have given more consideration to the idea of maintaining the building until such a time as the strata is prepared to carry out a permanent solution involving a rain screen system.

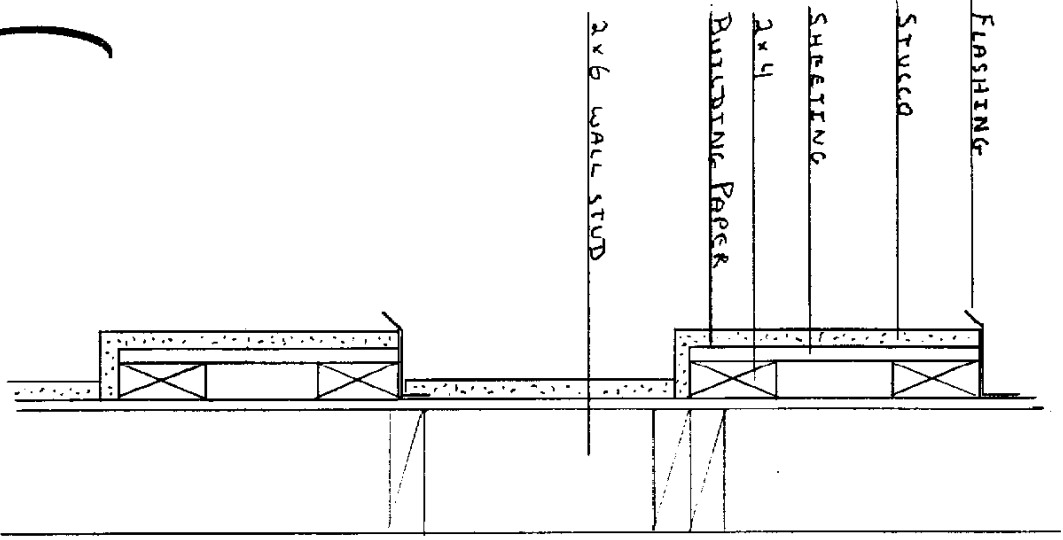
EXISTING BAND DETAIL

The decorative bands are a problem. They add details to the building including three bands of flashing to the entire perimeter. The bands are in close proximity to the bottom of the windows. The flashing profile at the windows was changed to allow for easy installation. The installation incorporated simple lap joints under each window. The lap joints rely on caulking to stop water. The continual expansion and contraction of the metal flashing has caused the caulking to break down and begin to fail. The flashing was installed with no slope. Settlement and shrinkage of the building has resulted in much of the flashing sloping back towards the building allowing it to hold water. Three solutions present themselves to contend with this problem

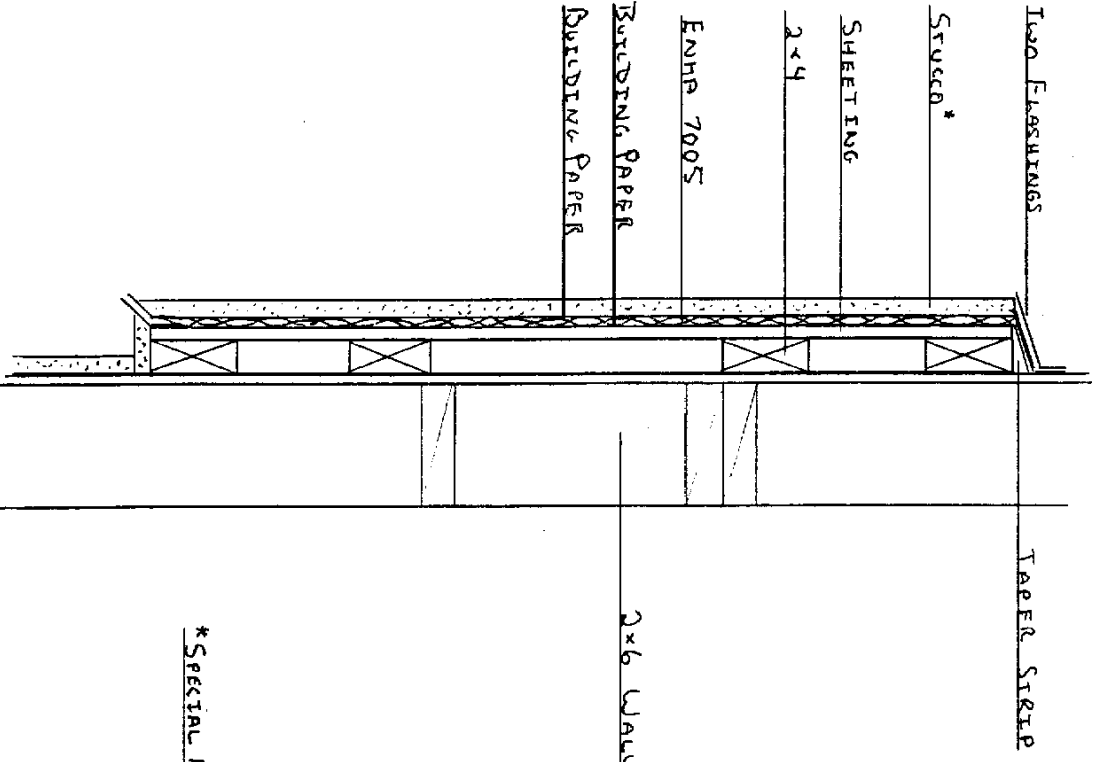
PROPOSED BAND DETAIL

- 3) The band could be rebuilt to a new design (see design attached). This design would in effect address all of the problems with the bands, eliminate one row of flashing around the perimeter and allow water that is infiltrating above the bands to drain off the building at the band level, reducing trapped water and allowing some drying.

I trust that the above repair or maintenance options give the Strata the information required to take the next step. If there is something that is not clear or you required more information on please let me know. The final page is the design change for the decorative bands. Although not shown, part of this design would include lowering the top 2 x 4 to create more space between the band and the bottom of the windows. The top of this detail could also be used for the lower band.
