# Hampton Court and Churchill Place

# Building Enclosure Condition Assessment

545 Manchester Road and 520 Dunedin Street Victoria, B.C.

March 10, 2021 RJC No. VIC.125902.0001

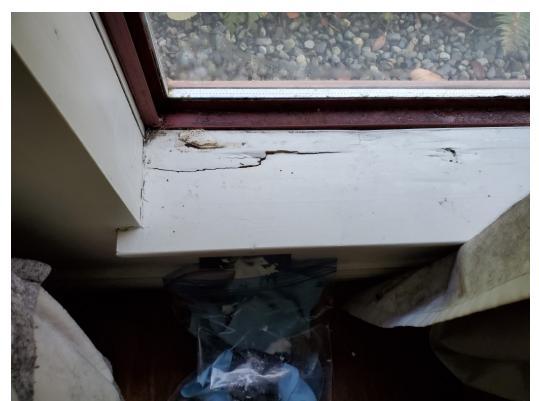
Photo 03 - Wood stool damaged by condensation

.1 Wood sills/stools along the bottom edge of the interior of the windows have localized moisture staining and damage, primarily due to condensation on the interior surface of the windows. Interior windows primarily located in poorly ventilated areas such as bedrooms and on low sunlight building elevations are subject to increased condensation and further damage to wood sills/stools (Photo 03). In locations prone to increased condensation, the moisture content of the wood sills/stools was high (>19%).

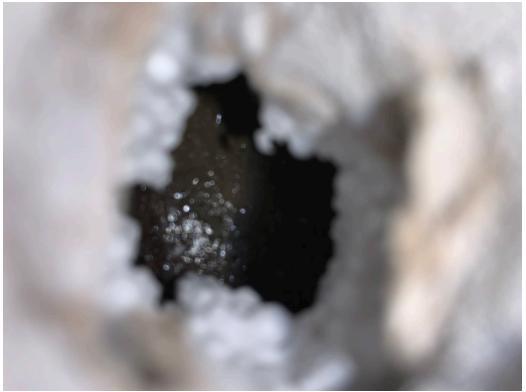
.2 Interior wall recesses cut in first floor units near the at grade concrete wall assemblies indicated damage to wood sills, increased interior condensation on the interior surface of windows, and high moisture content of the interior drywall (>12% WME) due to the buildup of condensation on the interior face of the at grade concrete wall assembly (Photo 04). Condensation builds up on the interior face of the at grade concrete wall assembly when the concrete is cooled due to low exterior temperatures causing the warmer air of the interior wall assembly to condensate on the interior surface of the concrete.

Photo 04 - Condensation on the interior face of at grade concrete wall assembly

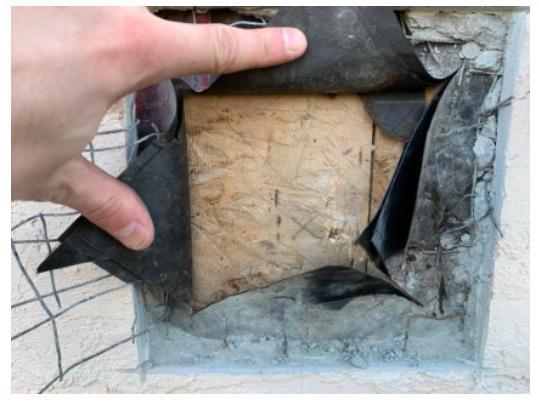
Photo 06 - Typical Recess Condition

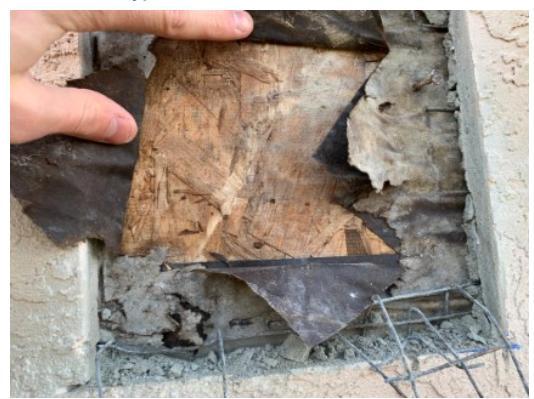
The exterior exploratory recesses reveal that in general, the wall's performance varies from poor to good, based on the proximity to windows and other penetrations. At most locations, the building paper was aged and appeared to have wetted and dried, the metal lath showed minor corrosion, the sheathing showed minor staining and had a low/normal moisture content (<19%) (Photo 06). Locations situated below windows, in areas of visible staining on the face of the stucco, and near cracks in the stucco, generally had deteriorated building paper, corrosion on the metal lath, and the sheathing showed significant staining and elevated moisture content (Photo 07).

Photo 07 - Recess with Evidence of Water Ingress

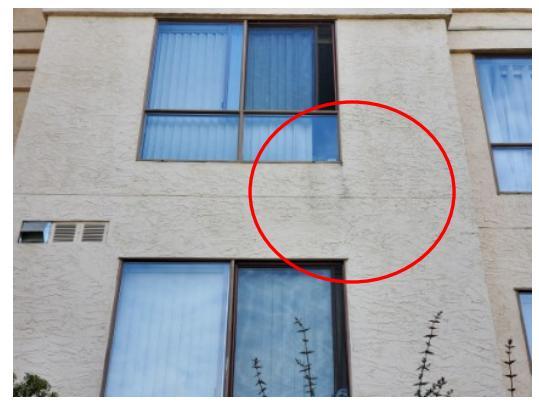
The recess openings below windows indicate that there is some moisture ingress from the windows occurring. Typically, windows had very limited head flashings and did not appear to have any sill flashing, which may be contributing to water ingress of the areas below the windows (Photo 08).

Photo 08 - Typical Window Without Sill Flashing

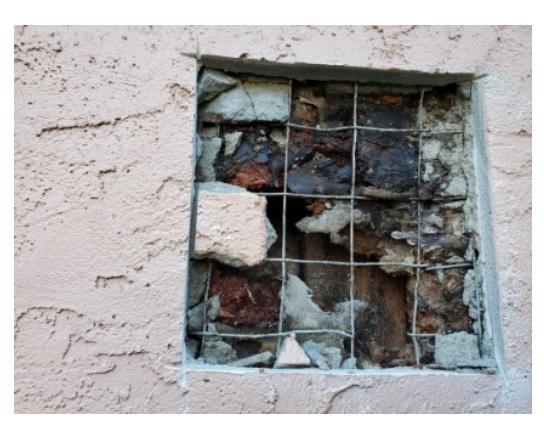
Wood framed balconies typically did not show signs of elevated moisture ingress or staining. However, at one balcony on the North elevation of Hampton Court at Unit 215, the sheathing and building paper were completely deteriorated, allowing full view of the inside of the balcony (Photo 09). The structural framing in this location appeared to be completely wet and spongy/rotten. For more information on this balcony, please see *Appendix D – Exterior Recess Review*.

Photo 09 - Deteriorated Balcony at Hampton Court

A recess cut into the balcony on the North elevation of Hampton Court at Unit 215 revealed significant deterioration of sheathing and structural framing and is further documented in *Appendix D* – *Exterior Recess Review*. However, no significant leaks were observed on the underside of the soffit. An infrared survey later confirmed the extent of the moisture (Photo 19 in Section 2.3). The exact cause of the leak was not confirmed, however, it could be assumed it is the result of a targeted vinyl membrane failure and/or cap flashing imperfections.

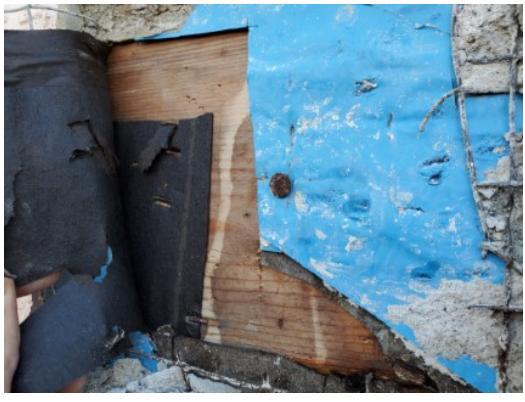
One opening was cut into the level 2 floor line at Unit 217 of Hampton Court, in what appeared to be a location of a previous exploratory opening, allowing review of the structural 2"x10" rim board. The original building paper was deteriorated, the metal lath was corroded, and the structural framing was saturated and beginning to deteriorate (Photo 10).

Photo 10 - Wet Structural Framing at Hampton Court

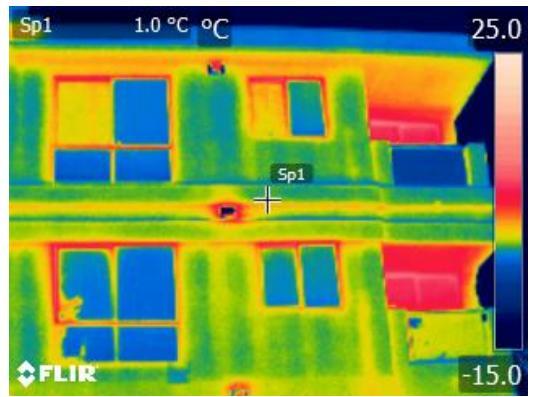
Photo 11 illustrates thermal losses are occurring at the windows and underside of balconies, as well as along the vertical wood studs. Losses at the windows are occurring because the aluminum framing is non-thermally broken, allowing heat to transfer from the warm area (inside) to the cool area (outside) through conduction. Losses are likely occurring at the underside of balconies as a result of insufficient insulation at balcony framing penetrations. Minor losses along wood studs are

Photo 11 - Thermal Bridging at Windows, Balconies, and Studs

occurring as a result of wood studs being more conductive that the surrounding insulation. This allows heat from the building's interior to flow outward through the wall assembly at the studs.

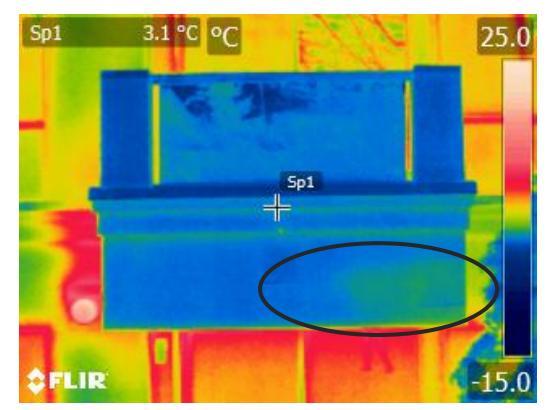
Photo 12 - Warm Location on Balcony Indicating Moisture

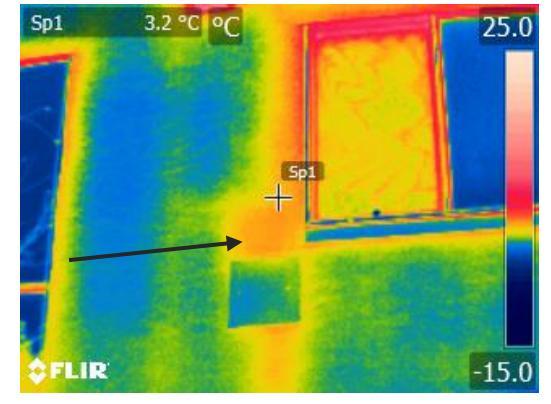
Photo 13 - Warm Location on Wall Indicating Moisture

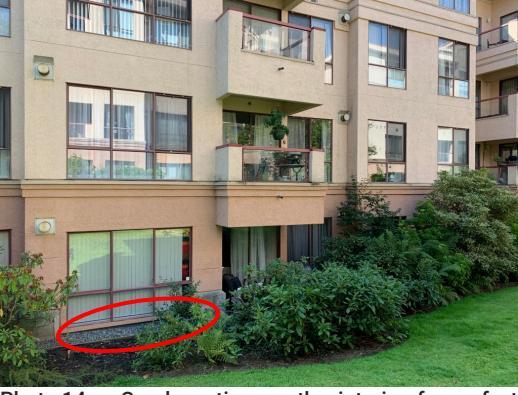
Photo 14 – Condensation on the interior face of at grade concrete wall assembly

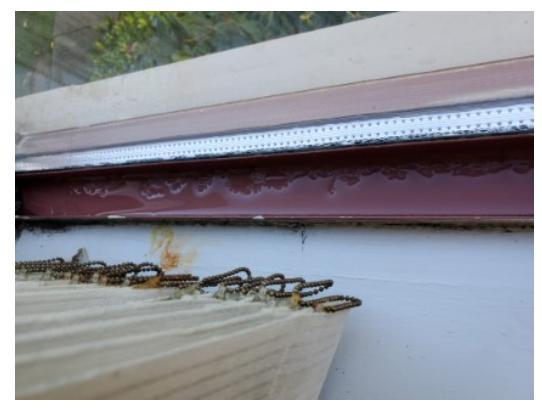
Photo 16 – Condensation Accumulation in Window Track

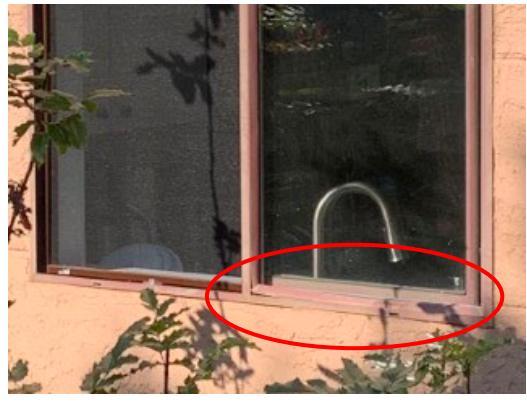
Photo 17 - Loose Glazing Stop

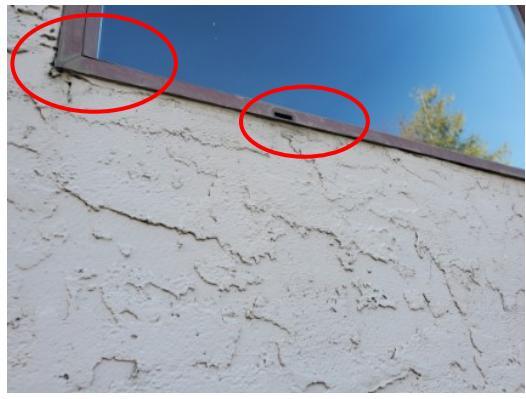
service life (approximately 30 years) the window frame mitre joints and their seals tend to fail towards the end of the expected life of the window system as they undergo thermal expansion and contraction, and normal ageing through their lifespan.

Photo 18 – Window Mitre Joint and Weep Hole

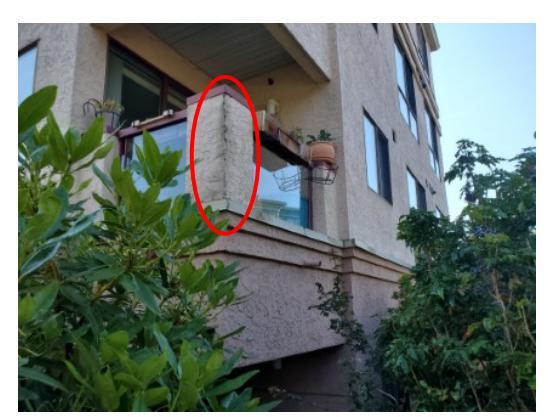
Photo 20 - Staining on Balcony Guardwall

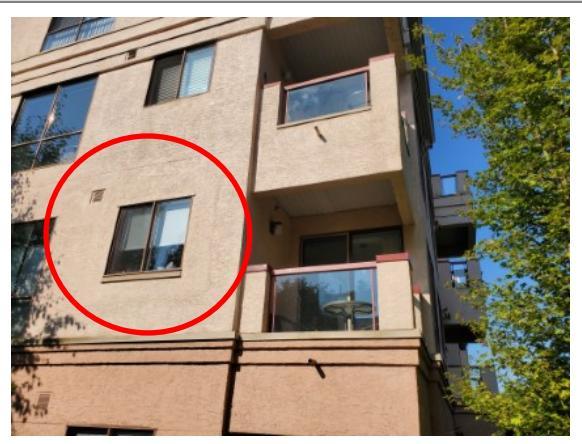
Photo C-3

Targeted stucco patches observed throughout. Likely from previous remedial repairs. Improved flashings at head and sill of window are present.

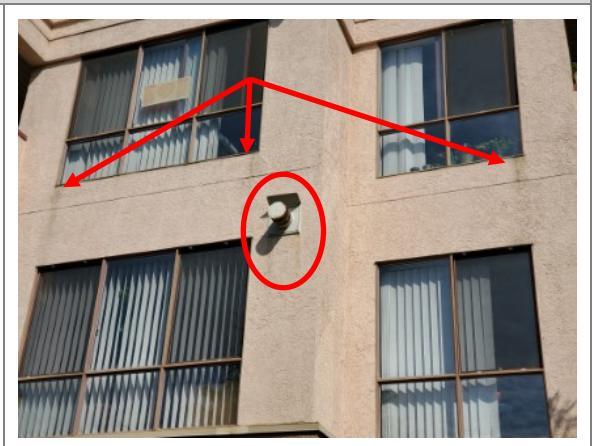
Photo C-9

Staining beneath exterior vent. Possibly the result of fastener corrosion.

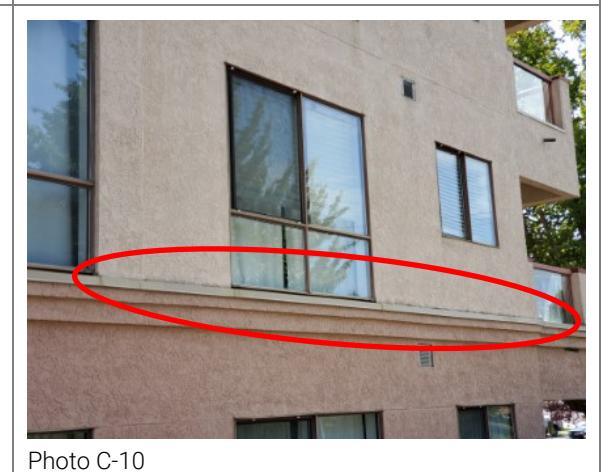
Churchill Place – West Elevation Level 2 Floor Line

Staining and deterioration of stucco finish above horizontal flashing at floor line.

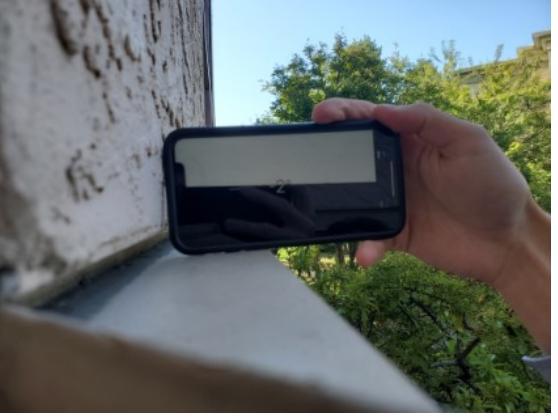
Photo C-11

Negatively sloped flashing observed throughout (2° inward shown).

This will prevent water from effectively shedding off the building, increasing the possibility of leaks into the building envelope.

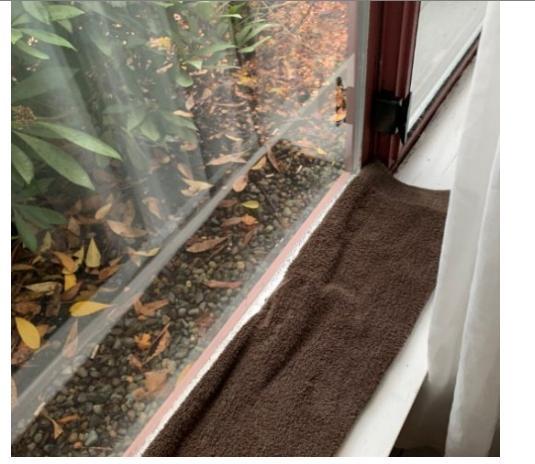
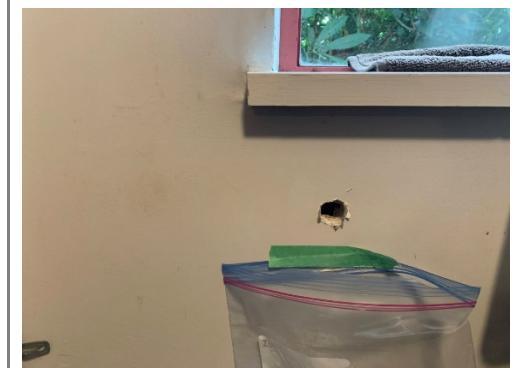
- Signs of condensation were present on the bedroom window sill located on the South elevation of the building.
- Signs of organic growth to the trim were observed. The moisture content of the wood trim was measured as 26%.
- The interior side of the base of wall concrete located below the bedroom window was wet to the touch.
- The moisture content of the wood framing below the window was measured as 21.9%
- The moisture content of the interior drywall below the window was measured as 14%

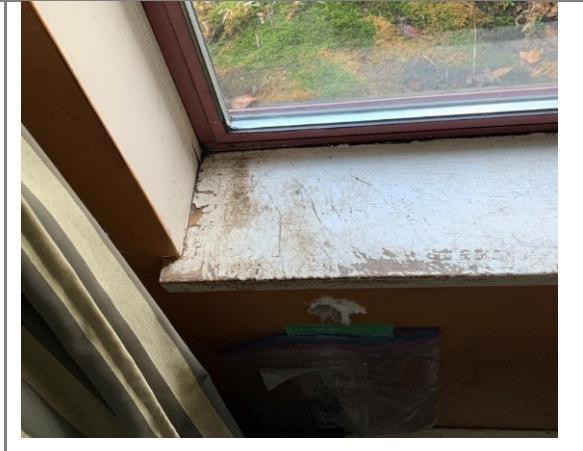
Photo E-4

- The finishes of the wood trim at the living room window sill were deteriorated. The moisture content of the wood trim was measured as 14.0%.
- The interior side of the base of wall concrete located below the living room window was dry.
- The moisture content of the wood framing below the window was measured as 19.8%
- The moisture content of the interior drywall below the window was measured as 12.2%

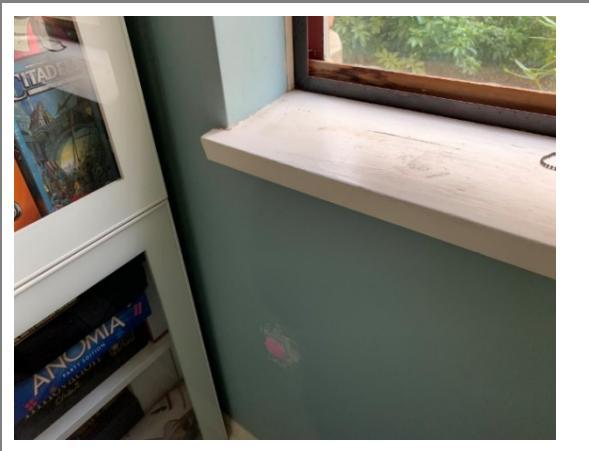
Photo E-6

- The living room window did not display signs of moisture related deterioration. The moisture content of the wood trim at the sill was 9.0%
- The interior side of the base of wall concrete located below the living room window was dry.
- The moisture content of the wood framing below the window was measured as 13.7%
- The moisture content of the interior drywall below the window was measured as 9.8%

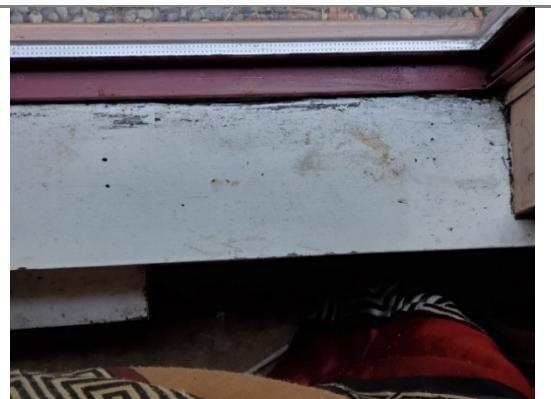
Photo E-11

- Signs of condensation were present on the bedroom window located on the East elevation.
- Signs of organic growth to the trim were observed.
- The moisture content of the wood trim was measured as 18.4%.
- The moisture content of the interior drywall below the window was measured as 16.0%
- Signs of condensation were present on the living room window on the south building elevation.
- Signs of organic growth to the window trim located at the living room window were observed.
- The moisture content of the wood trim was measured as 14.5%.
- The interior side of the base of wall concrete located below the living room window was dry.
- The moisture content of the interior drywall below the window was measured as 15.6%

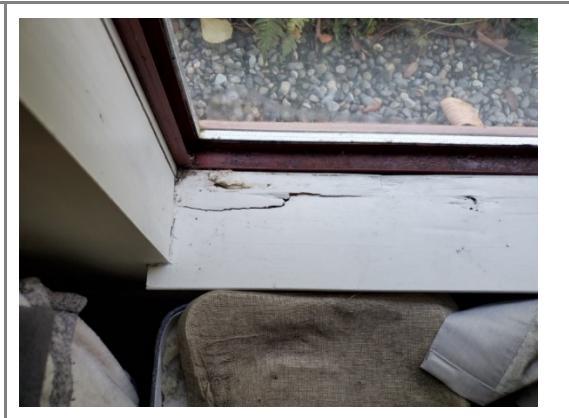
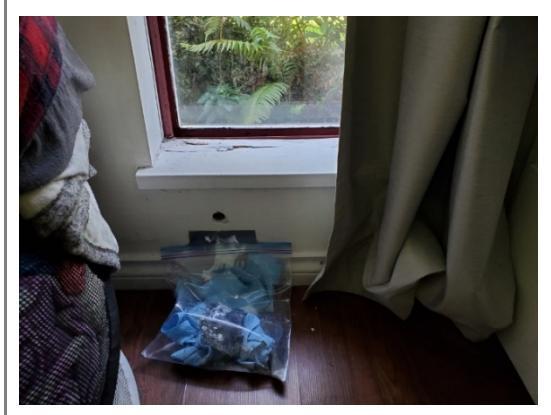
- Significant signs of condensation were present on the bedroom window located on the East elevation.
- The wood trim below the window was rotting and cracked.
- The moisture content of the wood trim was measured as 14.6%.
- The interior side of the base of wall concrete located below the living room window was dry.
- The moisture content of the interior drywall below the window was measured as 16.7%
- The moisture content of the wood framing below the window was measured as 11.1%

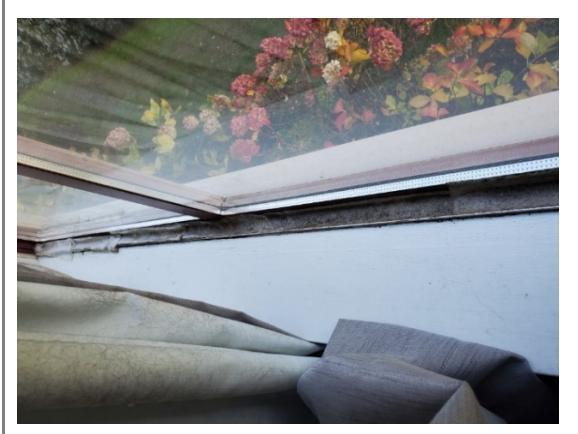
Photo E-17

- Significant signs of organic growth were present on the bedroom window sill located on the East elevation.
- The moisture content of the wood trim was measured as 9.4%.
- The moisture content of the OSB sheathing below the window was measured as 23.0%
- The moisture content of the wood framing below the window was measured as 21.8%
- The living room window located on the South building elevation did not show signs of moisture related deterioration.

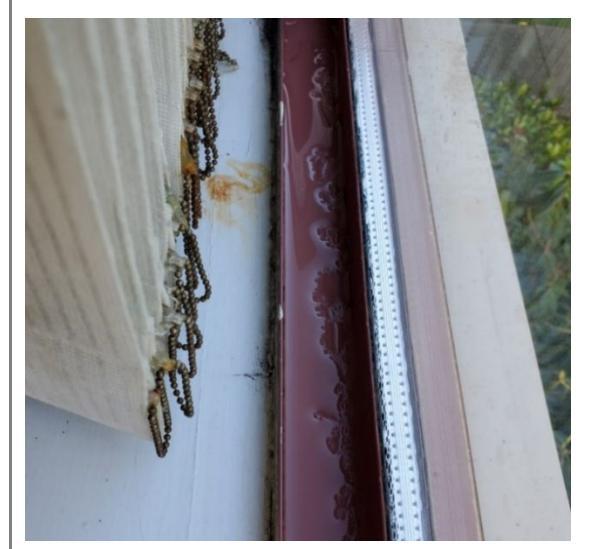
Photo E-19

- Significant signs of condensation were present on the windows located on the East elevation of the building.
- Signs of organic growth were present on the sills of windows located on the East elevation.
- The moisture content of the wood trim was measured as 17.2%.
- The moisture content of the interior drywall below the window was measured as 19.6%
- No significant signs of moisture deterioration were observed on the kitchen window located on the South elevation of the building.
- The moisture content of the wood trim was measured as 10.5%.
- The moisture content of the OSB sheathing below the window was measured as 22.4%
- The moisture content of the wood framing below the window was measured as 10.5%
- The moisture content of the interior drywall below the window was measured as 15.0%

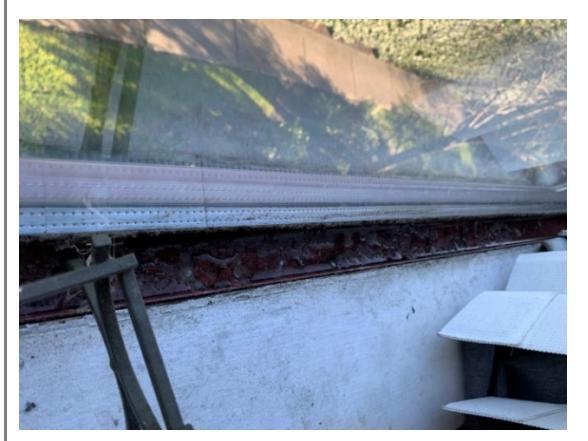
Photo E-20

- Significant signs of condensation were present on the bedroom window located on the East elevation of the building.
- Signs of organic growth were present on the bedroom window.
- The moisture content of the wood trim was measured as 15.5%.
- The moisture content of the interior drywall below the window was measured as 16.7%
- The moisture content of the OSB sheathing below the window was measured as 21.0%

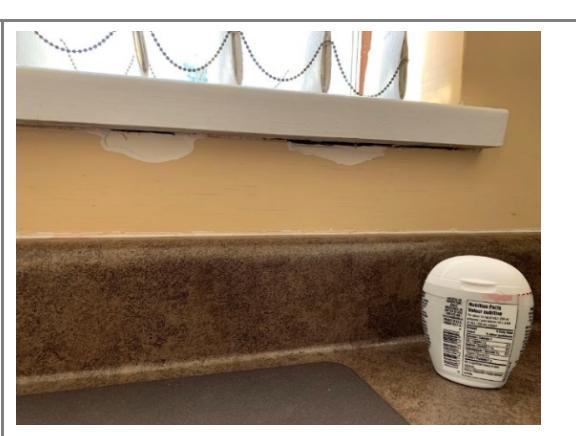
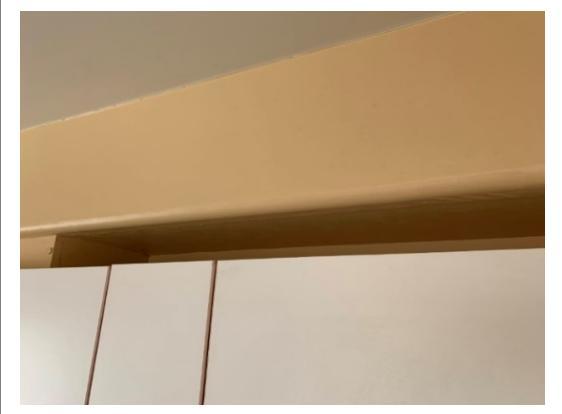
- Signs of condensation were present on the kitchen window located on the West building elevation.
- Paint beneath the window trim was observed to be cracked and peeling.
- Signs of moisture related deterioration were observed on the kitchen bulkhead located above the cabinetry.
- Cracking to the interior drywall was observed beneath the bedroom window located on the West elevation of the building.
- The moisture content of the interior drywall below the window was measured as 10.9%
- The moisture content of the OSB sheathing below the window was measured as 23.7%
- The moisture content of the wood framing below the window was measured as 10.8%
