Depreciation Report Level I

Prepared for Strata VIS 2720's 2013 Fiscal Year

27/1/2014

Strata VIS 2720
545 Manchester Road and 520 Dunedin Street
Victoria, B.C.

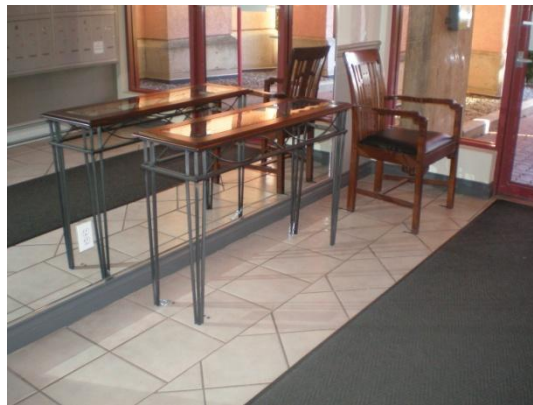
Interior Furnishings: Refurbish

Quantity	2 allowance	UL	20
Current Cost	\$1,000.00	RUL	19

This is an aesthetical item that may be adjusted based on the Strata's desires. At this time, we suggest reserve funding at the following level.

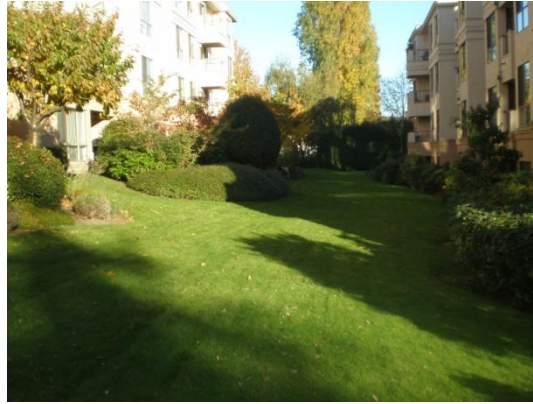
Landscaping: Refurbish			
Quantity		UL	n/a
Current Cost	\$0.00	RUL	n/a

We understand that the Strata adjusts the landscaping component of the operating budget annually and therefore there is no need for a recurring amount in the Reserve Fund

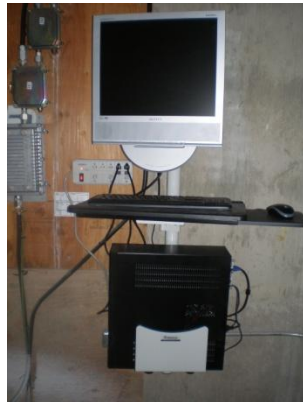
Security System: Replace			
Quantity	2 each	UL	10
Current Cost	\$10,000.00	RUL	10

We understand that the Strata is in the process of selecting vendors and equipment. The new equipment will become obsolete in approximately 10 years as technology improves.
