# Hampton Court and Churchill Place

# Building Enclosure Condition Assessment

545 Manchester Road and 520 Dunedin Street Victoria, B.C.

March 10, 2021 RJC No. VIC.125902.0001

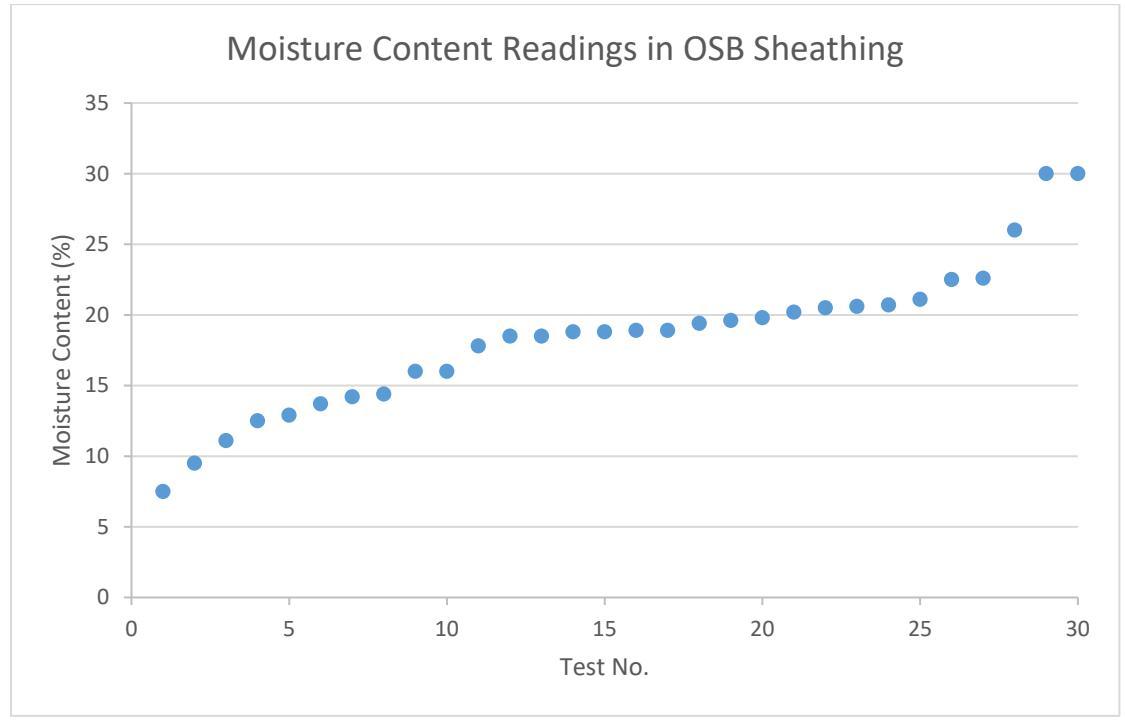
Figure 04 - Moisture Content Readings in OSB Sheathing

Table 4 - Moisture Content Readings				
	Number of Recesses	% of Recess		
MC <19%	17	56.6%		
>19% MC <28%	11	36.6%		
MC >28%	2	6.8%

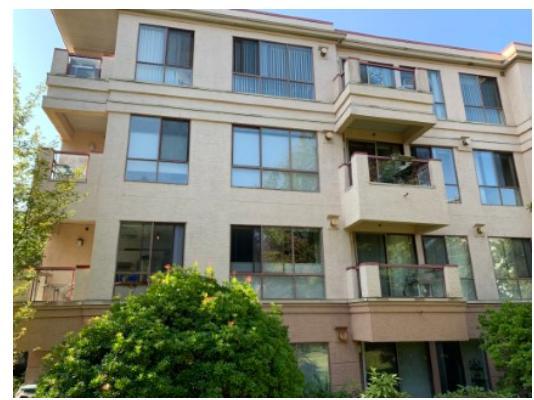
The balconies in general are in good condition with only one issue with respect to the waterproofing system observed. Soffits appear to be clean and there were no signs of water penetrating through the wood framing due to failure in the membrane.

Photo 19 - Typical Balcony Stacks

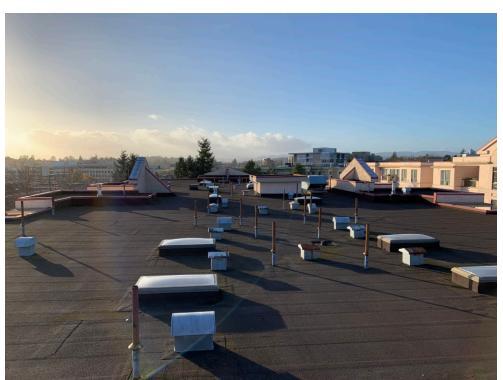
The age of the existing roof assembly was indeterminate. The assembly is conventional roof system which incorporates a two-ply torch applied membrane with rigid insulation (Photo 21).

In general, the main roof assemblies are in good condition. No pooling of water on the membrane was observed at the time of the visit and water appears to be draining adequately. However, RJC observed signs of organic growth build-up on the surface of the membrane in poor drainage locations.

Photo 21 - General roof layout

Although the roof assembly is showing no major signs of damage, some localized areas of blistering of the membrane were observed and will require localized repairs to prevent accelerated deterioration of the assembly. Blisters are at more risk of puncture than flat, well-adhered membrane and indicate potential leaks or other imperfections below. Blister repairs generally require localized removal of the membrane to investigate conditions and the application of a patch to reinstate the membrane.

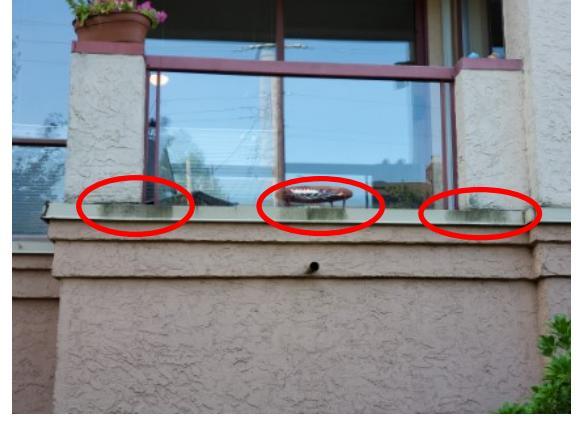
Typical staining on flashing tape.

This was consistent at most locations

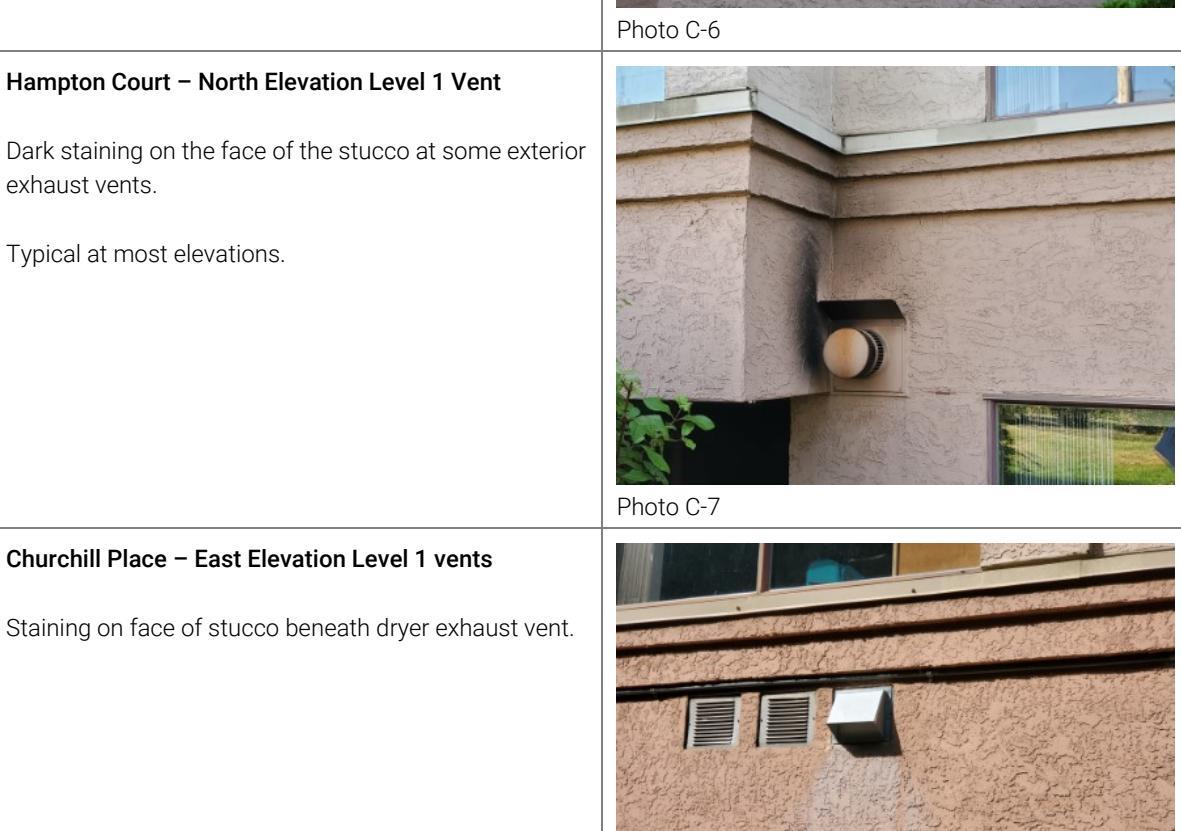
#### Hampton Court – North Elevation Level 1 Vent

Dark staining on the face of the stucco at some exterior exhaust vents.

Typical at most elevations.

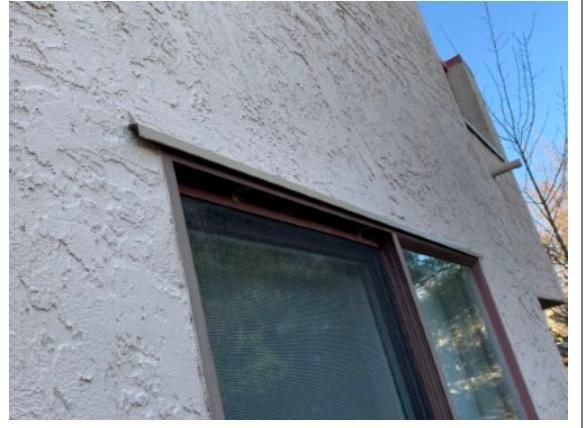
Photo C-15

Reglet window head flashing.

Appears to have been installed post-construction in some locations.

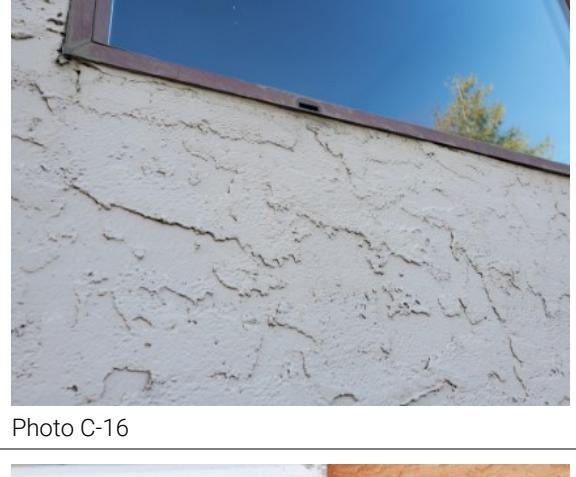
#### Hampton Court – South Elevation

Typical aluminum window sill with weep hole.

No sill flashings present at most windows. This is the condition per original construction.

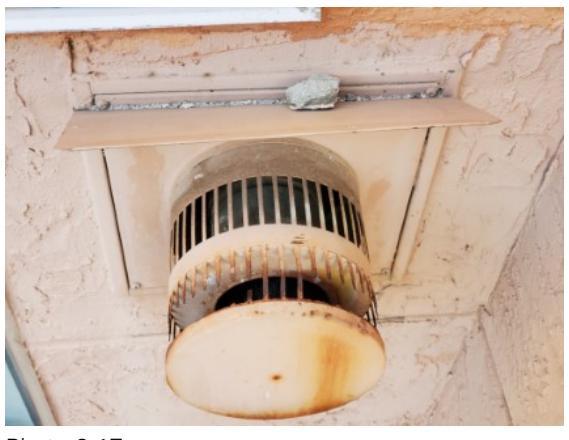
#### Hampton Court – South Elevation Level 2 Vent

Corrosion and complete deterioration of thin metal on some exterior vents.

Typical at most elevations.

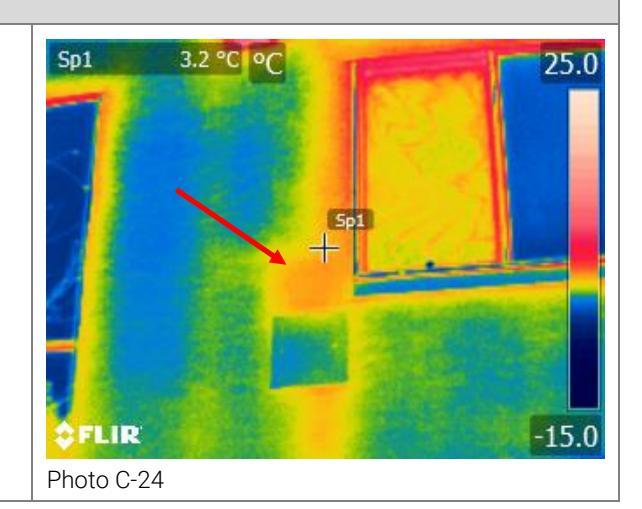
#### Hampton Court – East Elevation

Warm spot on stucco wall confirms extent of wet location in wall assembly documented in exploratory opening #26.

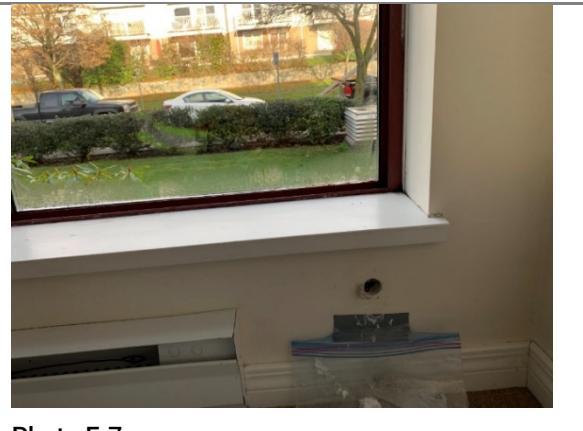
- Signs of condensation at the bedroom window sill were observed. The moisture content of the wood trim at the sill was 19.1%
- The moisture content of the OSB sheathing was 21.7%
- The moisture content of the interior drywall below the window was measured as 16.4%
